THE MACINTOSH
BIBLE GUIDE
TO SAVING A FORTUNE
ON MAC REPAIRS

THE DEAD MAC SCROLLS

HOW TO FIX HUNDREDS
OF HARDWARE PROBLEMS
WITHOUT GOING BANKRUPT

LARRY PINA

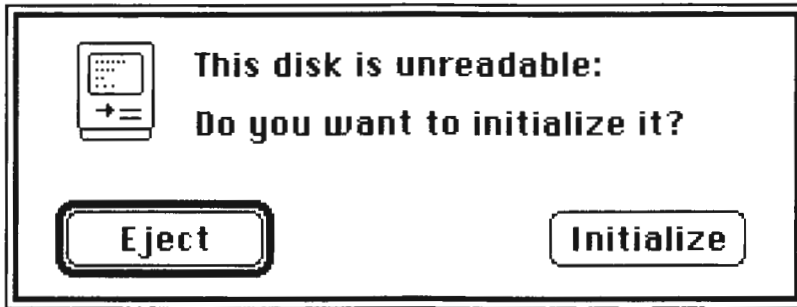
Probable diagnosis: The problem is on the SE logic board.

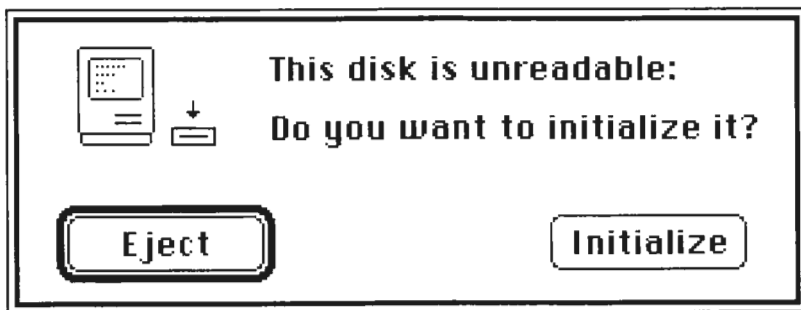
Probable diagnosis: The problem is on the SE logic board.

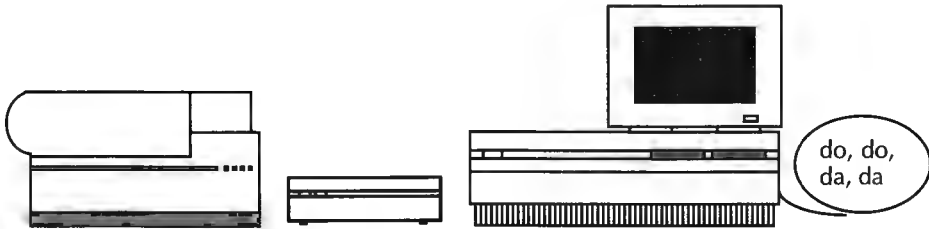
Typical history: The problem occurred when you installed a second or third external SCSI device (generally a LaserWriter IISC or a Personal LaserWriter SC).

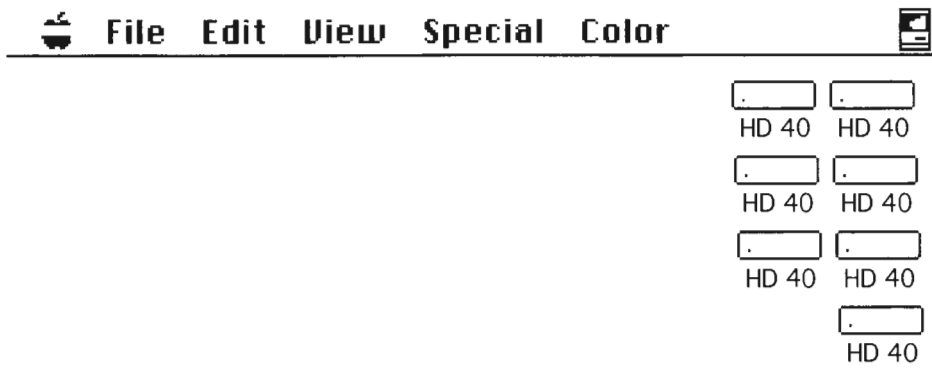
Typical history: The problem occurred when you installed an external SCSI drive.

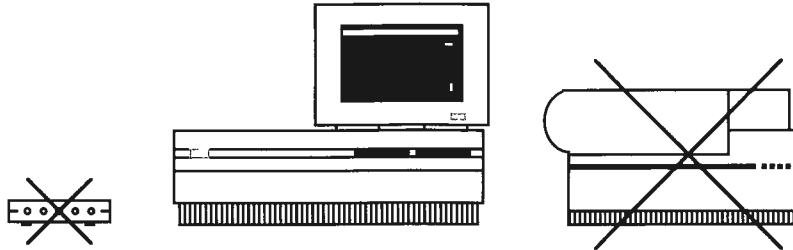
Probable diagnosis: The problem is on the Mac II logic board.

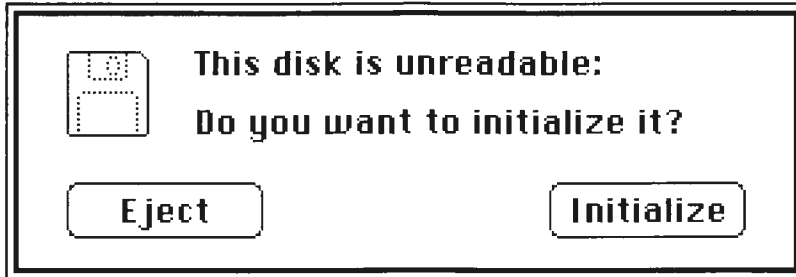
Typical history: The problem started right after a stuck disk was forcibly ejected from the drive (yanked out with pliers).

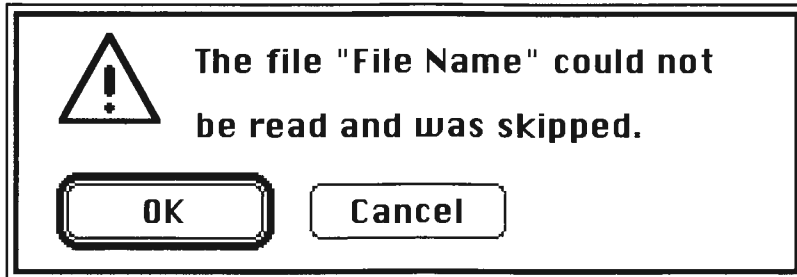
Typical history: The problem may have developed gradually, or it may have started right after the drive was serviced.

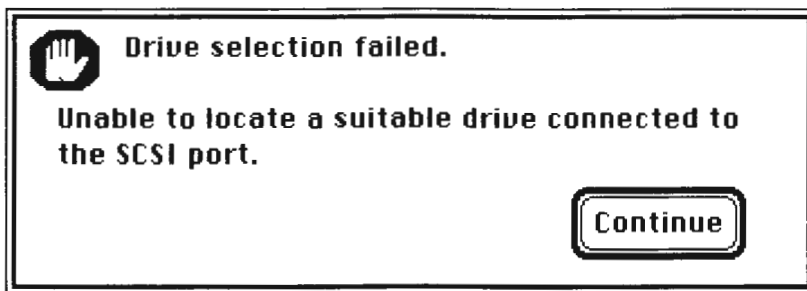
Probable diagnosis: The SCSI driver has been damaged or replaced by optimizer software, protection software or a generic SCSI utility.

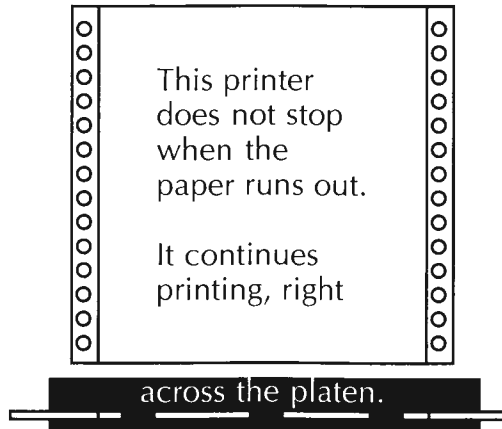
Probable diagnosis: The paper error detector is malfunctioning. Most likely, a mailing label got stuck under the platen and the detector arm is jammed by a piece that's still in there.

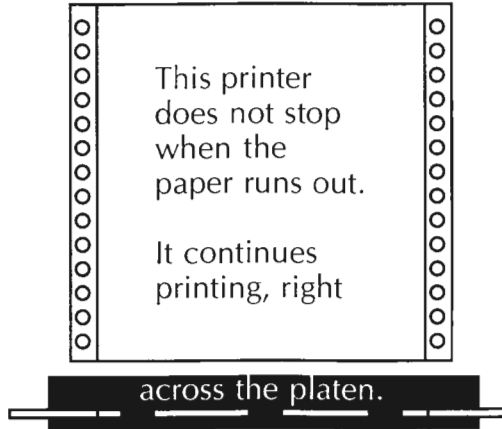
Probable diagnosis: The paper empty sensor is malfunctioning. Most likely, a mailing label is stuck under the platen.

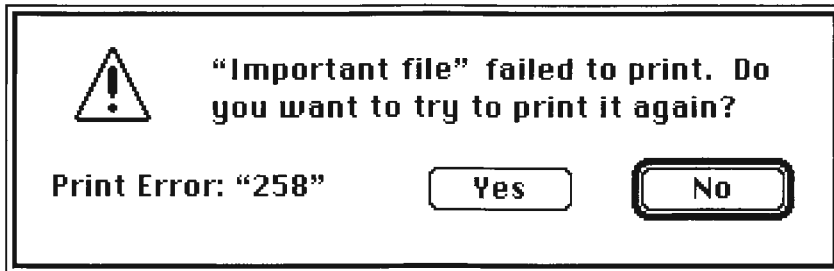
Probable diagnosis: The problem is on the LaserWriter II SC logic board.
