THE MACINTOSH
BIBLE GUIDE
TO SAVING A FORTUNE
ON MAC REPAIRS

THE DEAD MAC SCROLLS

HOW TO FIX HUNDREDS
OF HARDWARE PROBLEMS
WITHOUT GOING BANKRUPT

LARRY PINA

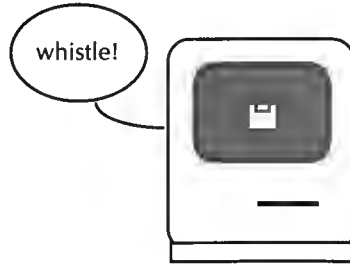
Symptoms: On startup, the computer *momentarily* makes a loud whistle noise (like a teakettle). Otherwise, it seems OK.

Probable diagnosis: The problem is on the analog board.

Solution: Replace the tunable coil (marked *Width*) at board reference L2 with a later type made of Litz wire.

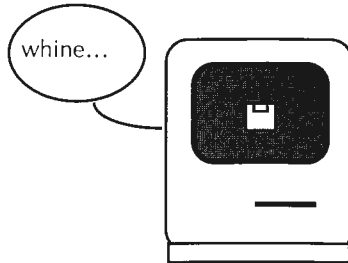
Symptoms: Occasionally, the computer makes a high-pitched whining noise (like a mosquito). Otherwise, it seems OK.

Probable diagnosis: The problem is on the analog board.

Solution: Replace the flyback transformer (Apple part 157-0026-B) at board reference T1 with a later type (157-0042-C).

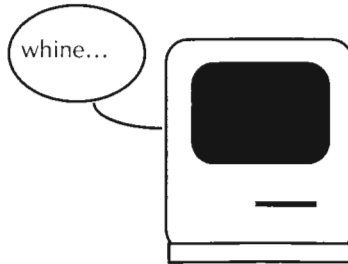
Symptoms: There is a normal startup bong, but the display is dark. The computer makes a high-pitched whining noise (like a mosquito). After a few minutes, there is a burning smell.

Probable diagnosis: The problem is on the analog board.

Solution: Replace the flyback transformer at board reference T1 and check/replace the BU406 transistor at board reference Q1.

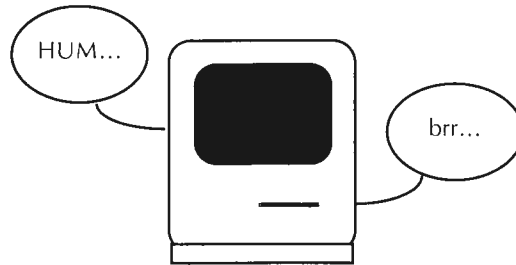
Symptoms: There is no startup bong. The display is dark. A loud AC hum is coming through the speaker. The internal 800K disk drive is making an unusual vibration noise.

Probable diagnosis: The problem is on the analog board.

Solution: With the power off, check resistance across CR5. If the reading indicates $44/45\Omega$ (not $3.6K/\infty$), replace the flyback transformer (Apple part 157-0026-B) at board reference T1.

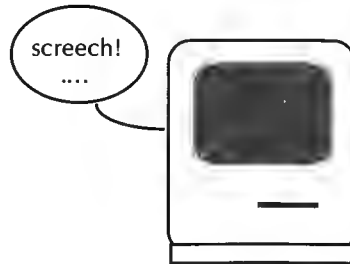
Symptoms: There's no startup bong. There's no video. The display is dark. The computer makes a *very loud* screeching noise.

Probable diagnosis: The problem is on the analog board.

Solution: With the power off, check resistance across CR5. If the reading indicates $44/45\Omega$ (not $3.6K/\infty$), replace the flyback transformer (Apple part# 157-0026-B) at board reference T1.

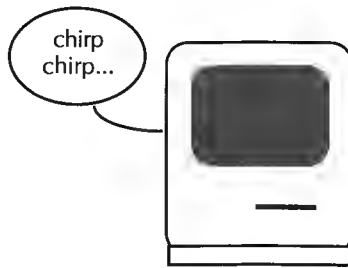
Symptoms: There is no startup bong. The display is blank. The computer makes a high-pitched *chirp chirp chirp* noise.

Typical history: The right side of the display used to move in and out whenever a window was opened.

Probable diagnosis: The problem is on the analog board.

Solution: Replace the barrel rectifier (G1854, R-SI, 600V, 3A) at board reference CR5 on the analog board. Use a heavy-duty replacement part (MR824, R-SI, 400V, 5A) to avoid future repairs.

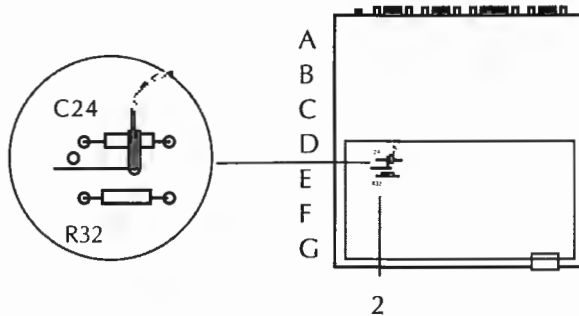
Probable diagnosis: The problem is in the wiring harness.

Solution: For a temporary fix, reseal the wire between C24 and R32 at board location D2 to E2 on the Macintosh logic board. For a permanent fix, solder the wire in place. If that doesn't do it, see the next entry.

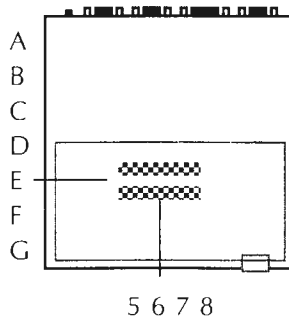
Symptoms: On a Mac 512Ke, there is no startup bong. The display is filled with a black-and-white checkerboard pattern.

Probable diagnosis: One of the pin headers isn't making contact.

Solution: For a temporary fix, reseal the boards at location E5 to E8 on the 512Ke logic board. For a permanent fix, replace the OEM pin headers with two 64-pin IC sockets. Reconnect the two boards with a 64-pin socket header.

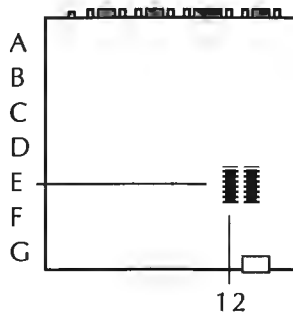
Probable diagnosis: The problem is on the 512Ke logic board.

Solution: Check for and repair damaged circuit traces near the 74LS244 chips at board locations E12 and E13.

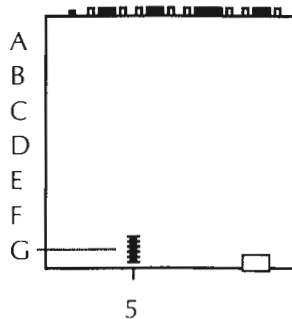
Symptoms: There are consistent (repeatable) system errors that do not occur (cannot be repeated) on other Macs. The logic levels on the 74F253 chip (16-pin DIP, dual 4-input multiplexer, tri-state) at board location G13 are wrong.

Probable diagnosis: The problem is on the 512K or 512Ke logic board. Most likely, circuit traces were cut by the screwdriver tip.

Solution: Check for and repair damaged circuit traces near the 41-256 DRAM chip at location G5.

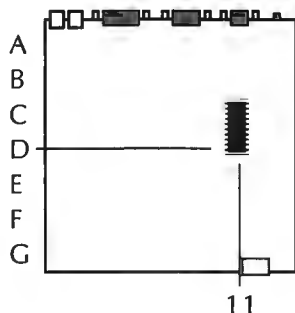
Probable diagnosis: The problem is on the Mac Plus logic board.

Solution: Replace the 6522-02PC chip (40-pin DIP, versatile interface adapter) at location D11.

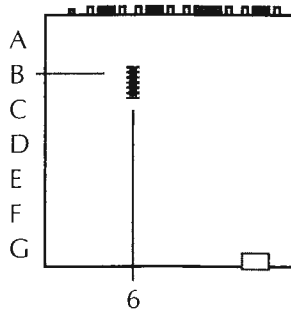
Probable diagnosis: The problem is on the 512K or 512Ke logic board.

Solution: Check/replace the 26LS30 chip (16-pin DIP, dual differential RS422 party line/quad single-ended RS423 line driver) at board location B6.

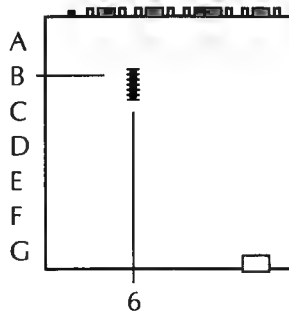
Symptoms: A Mac 128K, 512K or 512Ke does not show up on an AppleTalk network. Otherwise, it appears to be normal.

Probable diagnosis: The problem is on the logic board.

Solution: Check/replace the 26LS30 chip (16-pin DIP, dual differential RS422 party line/quad single-ended RS423 line driver) at board location B6.

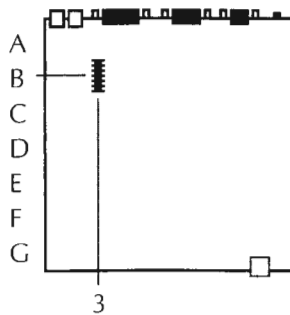
Symptoms: On startup, a Mac Plus resets several times any ImageWriter II directly connected to the printer port. The first time you try to print you get a dialog box stating: *The printer is not responding*, but subsequent tries made during the same computer session work fine. If the same ImageWriter II is reconnected to the modem port, it appears to work normally. An ImageWriter I also appears to work normally, on either port.

Probable diagnosis: The problem is on the Mac Plus logic board.

Solution: Check/replace the 26LS30 chip (16-pin DIP, dual differential RS422 party line/quad single-ended RS423 line driver) at board location B3.

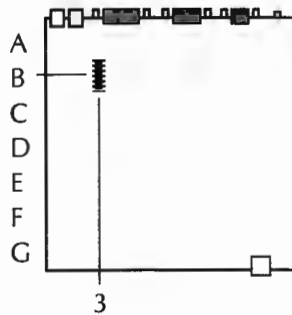
Symptoms: The Mac Plus does not show up on an AppleTalk network. Otherwise, it appears to be normal.

Probable diagnosis: The problem is on the logic board.

Solution: Check/replace the 26LS30 chip (16-pin DIP, dual differential RS422 party line/quad single-ended RS423 line driver) at board location B3.

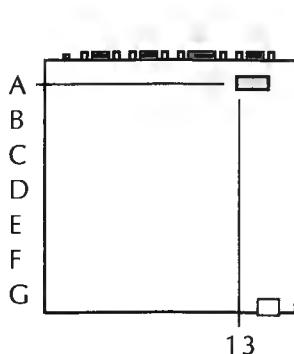
Symptoms: On a Macintosh 512Ke the internal 800K disk drive works OK, but known-good external 800K disk drives do not work. Regardless of what disk you insert into the external DD, all you get is: *This disk is unreadable. Do you want to initialize it?*

Probable diagnosis: The problem is on the 512Ke logic board.

Solution: Check/replace the RC filter (20-pin, DIP, Apple part 115-0002) at location A13.

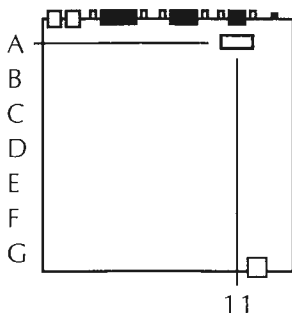
Symptoms: On a Macintosh Plus the internal 800K disk drive works OK, but external 800K disk drives that are known to be good do not work. Regardless of what disk you insert into the external DD, all you get is: *This disk is unreadable. Do you want to initialize it?*

Probable diagnosis: The problem is on the Mac Plus logic board.

Solution: Check/replace the RC filter (20-pin, DIP, Apple part 115-0002) at location A11.

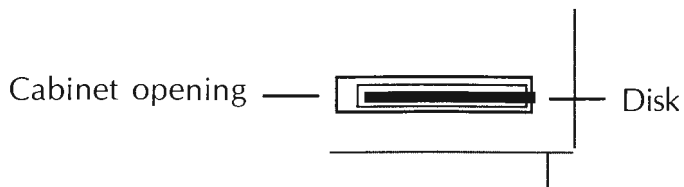
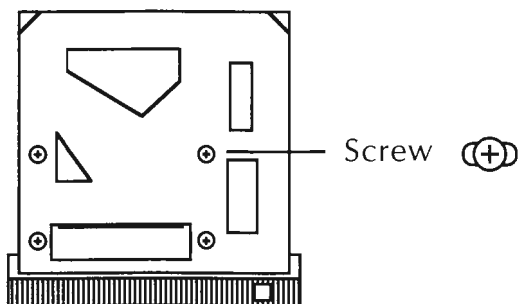
Symptoms: When floppy disks are inserted or ejected, they rub up against the cabinet opening.

Typical history: The problem occurred right after an 800K DD-ROM upgrade or a disk-drive swap.

Probable diagnosis: The disk drive isn't centered on the cabinet opening.

Solution: Loosen/reposition the disk drive mounting screws.

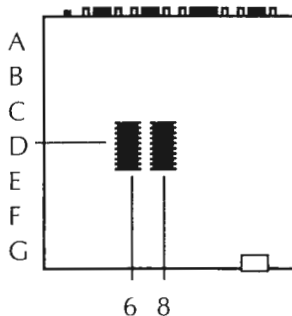
Symptoms: On a Macintosh 512Ke with a SCSI upgrade, if there's an external hard drive connected to the SCSI port, it won't boot from a floppy disk unless the hard drive is also switched on.

Probable diagnosis: The problem is on the 512Ke logic board.

Solution: Replace the version-1 ROMs (marked 342-0341-A and 342-0342-A) at locations D6 and D8 with a set of version-3 ROMs (marked 342-0341-C and 342-0342-B).

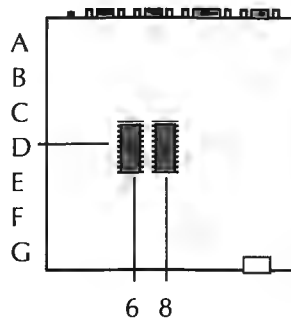
Symptoms: On startup, a 512Ke (with SCSI upgrade) will not boot if the computer is switched on first, or if the external hard drive is switched on simultaneously. But, if you switch on the hard drive, wait 30 seconds and then switch on the computer, everything works OK.

Probable diagnosis: The problem is on the 512Ke logic board.

Solution: Replace the version-2 ROMs (marked 342-0341-B and 342-0342-A) at locations D6 and D8 with a set of version-3 ROMs (marked 342-0341-C and 342-0342-B), or replace the hard drive.

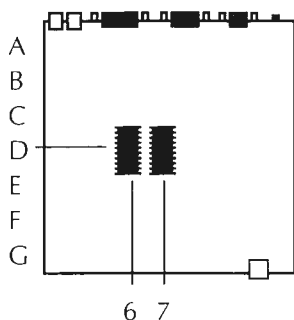
Symptoms: If there's an external hard drive connected to the SCSI port, a Mac Plus won't boot from a floppy disk unless the hard drive is also switched on.

Probable diagnosis: The problem is on the Mac Plus logic board.

Solution: Replace the version-1 ROMs (marked 342-0341-A and 342-0342-A) at locations D6 and D8 with a set of version-3 ROMs (marked 342-0341-C and 342-0342-B).

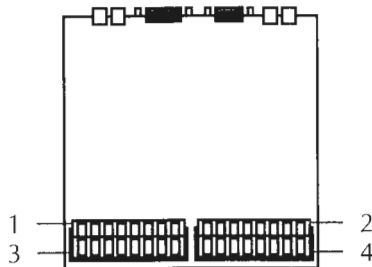
Probable diagnosis: The problem is on the SE logic board.

Solution: Check/replace SIMM 2 on 820-0176 (original) logic boards. Check/replace SIMM 4 on 820-0250 (DIP SIMM) boards.

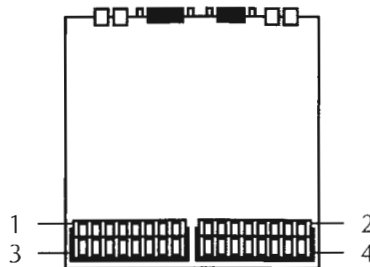
Symptoms: On startup, you get a sad Mac with error code 00000003 over nn00nn00 (where the values of nn are insignificant).

Probable diagnosis: The problem is on the SE logic board.

Solution: Check/replace SIMM 2 on 820-0176 (original) logic boards. Check/replace SIMM 4 on 820-0250 (DIP SIMM) boards.

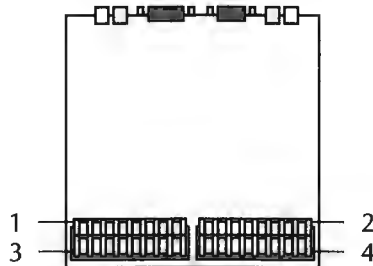
Symptoms: On startup, you get a sad Mac with error code 00000004 over 000000nn (where the value of nn is insignificant).

Probable diagnosis: The problem is on the Mac SE logic board.

Solution: Check/replace SIMM 3 on 820-0176 (original) logic boards. Check/replace SIMM 1 on 820-0250 (DIP SIMM) boards.

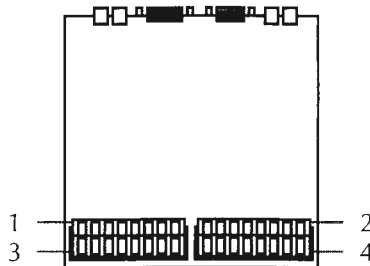
Symptoms: On startup, you get a sad Mac with error code 00000004 over 00nn00nn (where the values of nn are insignificant).

Probable diagnosis: The problem is on the Mac SE logic board.

Solution: Check/replace SIMM 3 on 820-0176 (original) logic boards. Check/replace SIMM 1 on 820-0250 (DIP SIMM) boards.

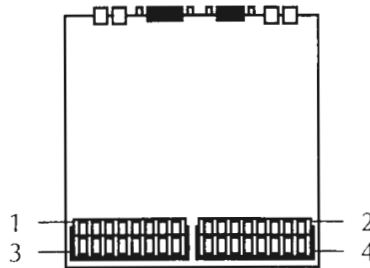
Symptoms: On startup, you get a sad Mac with error code 00000004 over 0000nn00 (where the value of nn is insignificant).

Probable diagnosis: The problem is on the Mac SE logic board.

Solution: Check/replace SIMM 4 on 820-0176 (original) logic boards. Check/replace SIMM 2 on 820-0250 (DIP SIMM) boards.

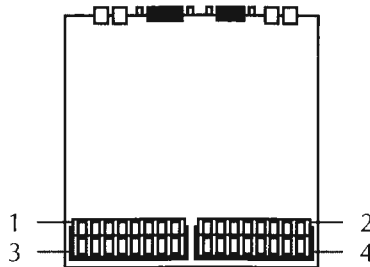
Symptoms: On startup, you get a sad Mac with error code 00000004 over nn00nn00 (where the values of nn are insignificant).

Probable diagnosis: The problem is on the Mac SE logic board.

Solution: Check/replace SIMM 4 on 820-0176 (original) logic boards. Check/replace SIMM 2 on 820-0250 (DIP SIMM) boards.

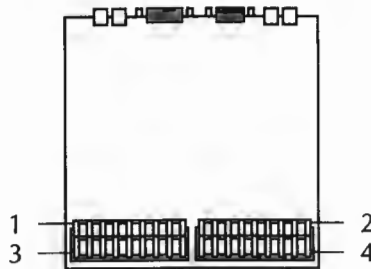
Symptoms: On startup, you get a sad Mac with error code 00000005 over 000000nn (where the value of nn is insignificant).

Probable diagnosis: The problem is on the Mac SE logic board.

Solution: Check/replace SIMM 3 on 820-0176 (original) logic boards. Check/replace SIMM 1 on 820-0250 (DIP SIMM) boards.

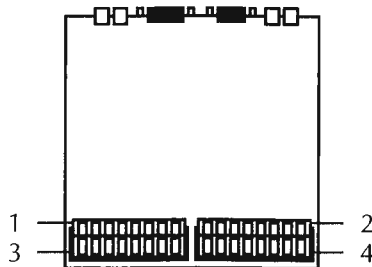
Symptoms: On startup, you get a sad Mac with error code 00000005 over 00nn00nn (where the values of nn are insignificant).

Probable diagnosis: The problem is on the Mac SE logic board.

Solution: Check/replace SIMM 3 on 820-0176 (original) logic boards. Check/replace SIMM 1 on 820-0250 (DIP SIMM) boards.

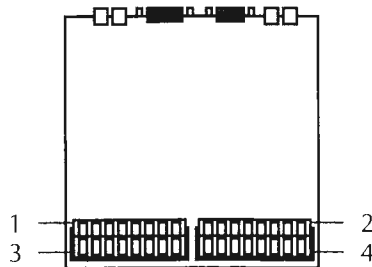
Symptoms: On startup, you get a sad Mac with error code 00000005 over 0000nn00 (where the value of nn is insignificant).

Probable diagnosis: The problem is on the Mac SE logic board.

Solution: Check/replace SIMM 4 on 820-0176 (original) logic boards. Check/replace SIMM 2 on 820-0250 (DIP SIMM) boards.

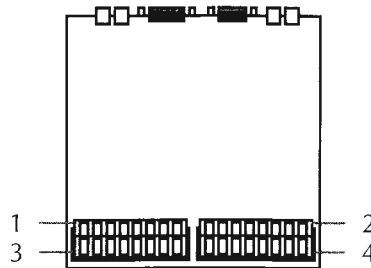
Symptoms: On startup, you get a sad Mac with error code 00000005 over nn00nn00 (where the values of nn are insignificant).

Probable diagnosis: The problem is on the Mac SE logic board.

Solution: Check/replace SIMM 4 on 820-0176 (original) logic boards. Check/replace SIMM 2 on 820-0250 (DIP SIMM) boards.

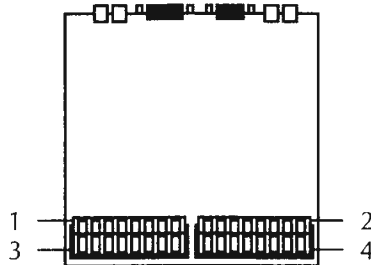
Symptoms: On startup, you get a sad Mac with error code 0000000E over 000000nn (where the value of nn is insignificant).

Probable diagnosis: The problem is on the SE logic board.

Solution: Check/replace SIMM 1 on 820-0176 (original) logic boards. Check/replace SIMM 3 on 820-0250 (DIP SIMM) boards.

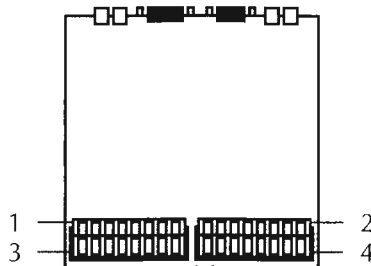
Symptoms: On startup, you get a sad Mac with error code 0000000E over 00nn00nn (where the values of nn are insignificant).

Probable diagnosis: The problem is on the SE logic board.

Solution: Check/replace SIMM 1 on 820-0176 (original) logic boards. Check/replace SIMM 3 on 820-0250 (DIP SIMM) boards.

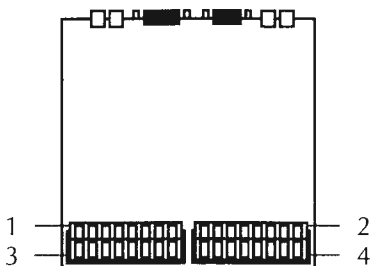
Symptoms: On startup, you get a sad Mac with error code 0000000E over 0000nn00 (where the value of nn is insignificant).

Probable diagnosis: The problem is on the SE logic board.

Solution: Check/replace SIMM 2 on 820-0176 (original) logic boards. Check/replace SIMM 4 on 820-0250 (DIP SIMM) boards.

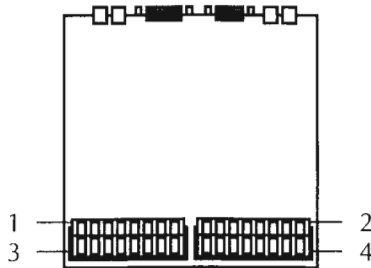
Symptoms: On startup, you get a sad Mac with error code 0000000E over nn00nn00 (where the values of nn are insignificant).

Probable diagnosis: The problem is on the SE logic board.

Solution: Check/replace SIMM 2 on 820-0176 (original) logic boards. Check/replace SIMM 4 on 820-0250 (DIP SIMM) boards.

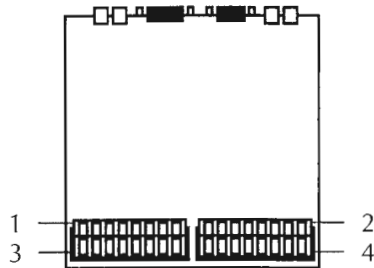
Probable diagnosis: The problem is on the Mac SE logic board.

Solution: Check/relatch SIMM 1 on 820-0176 (original) logic boards. Check/relatch SIMM 3 on 820-0250 (DIP SIMM) boards. If the latches are broken, replace the SIMM socket.

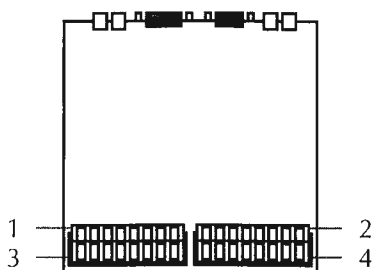
Symptoms: On startup, you get part of a sad Mac with error code 0_0_0_5 over F_0_F_0.

Probable diagnosis: The problem is on the Mac SE logic board.

Solution: Check/relatch SIMM 4 on 820-0176 (original) logic boards. Check/relatch SIMM 2 on 820-0250 (DIP SIMM) boards. If the latches are broken, replace the SIMM socket.

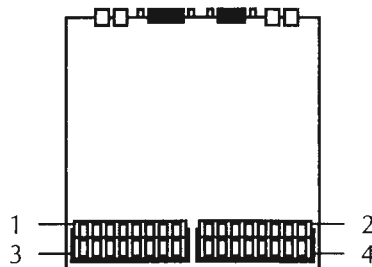
Symptoms: On startup, the display fills with vertical bars and the smiling Mac never goes away. It looks like the little guy is in jail.

Probable diagnosis: The problem is on the Mac SE logic board. The 1 MB SIMMs are in the wrong row.

Solution: Check/reinstall the SIMMs. On 820-0176 (original) logic boards, the 1 MB SIMMs go in sockets 1 and 2. On 820-0250 (DIP SIMM) logic boards, the 1 MB SIMMs go in sockets 3 and 4.

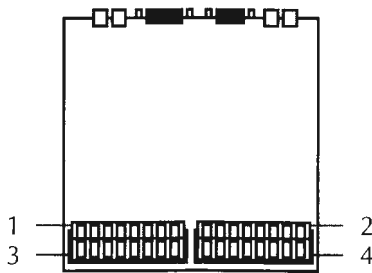
Symptoms: On startup, the computer makes a tweeting noise.

Probable diagnosis: The problem is on the Mac SE logic board. One of the SIMMs is bad.

Solution: Check the SIMMs by substitution.

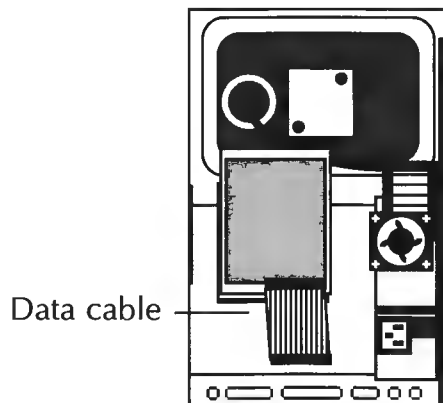
Probable diagnosis: The SCSI data cable is loose, or one of the wires is internally broken.

Solution: Check/replace the SCSI data cable.

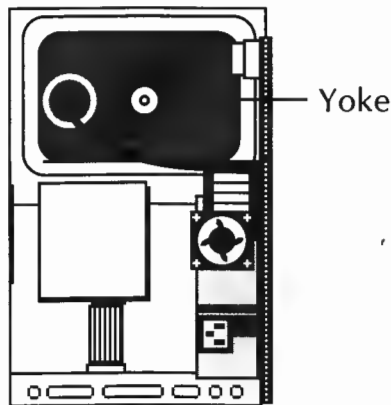
Symptoms: The display is tilted. Other than that, the Mac is usable.

Probable diagnosis: The yoke clamp (on the neck of the CRT) is loose.

Solution: Adjust/rotate the yoke for a square picture.

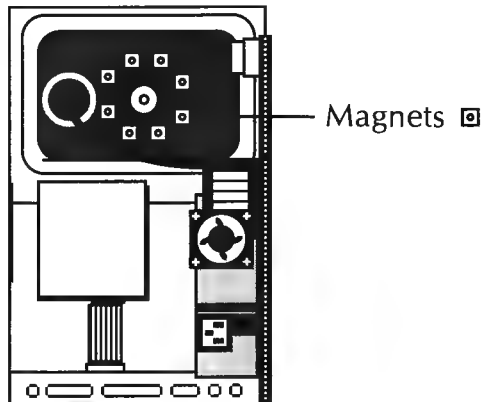
Symptoms: The display isn't rectangular. One or more of the edges is bowed. Other than that, the Mac is usable.

Probable diagnosis: One of the yoke magnets is loose.

Solution: Identify/adjust the loose yoke magnet.

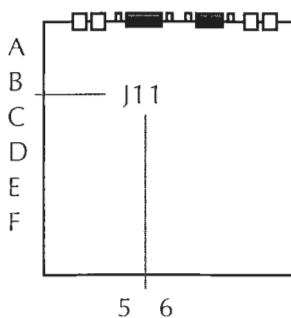
Symptoms: There's no startup bong and no beep (or other) sound. Otherwise, the raster is normal, and the computer is usable.

Probable diagnosis: The problem is on the logic board. The speaker cable is loose or disconnected.

Solution: Remove the logic board. Plug the speaker cable into J11.

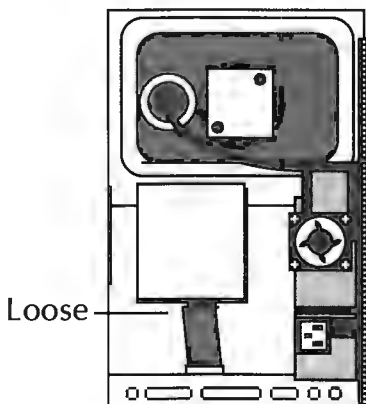
Symptoms: The upper disk drive doesn't work.

Probable diagnosis: During installation, the upper disk drive data cable worked loose.

Solution: Check the disk drive end of the data cable for a snug fit.

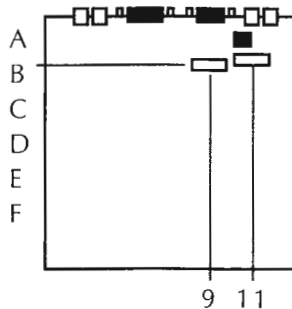
Probable diagnosis: The problem is on the SE logic board.

Solution: Check/replace the filter networks (20-pin DIP, Apple part 115-0002) at board references B9 and B11.

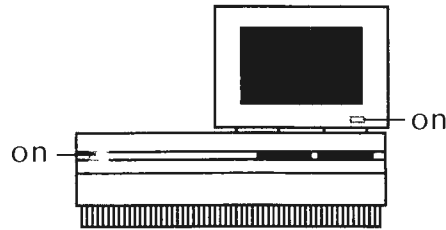
Symptoms: The normal startup chime is present, but the internal hard drive doesn't make mounting noises, the disk drive doesn't pulse and *raster never comes up* on the monitor(s). If you unplug the internal hard drive and restart from a System disk, the internal disk drive doesn't spin and raster still doesn't come up on the monitor(s). Either way, there are no error sounds.

Probable diagnosis: The problem is on a NuBus card.

Solution: Shut down/remove the installed NuBus cards one at a time until normal operation is restored.

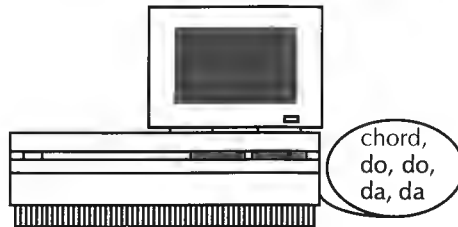
Symptoms: On startup, the normal startup chime is *quickly* followed by an error chord, then a *do-do-da-da* sound. The internal hard drive doesn't make its usual noises. The disk drive doesn't pulse. Raster never comes up on the monitor(s).

Typical history: The problem occurred out of the blue.

Probable diagnosis: There's a dust short on the logic board.

Solution: Remove the lid and the drive bay. Take the CPU cabinet outdoors and blow out the dust with an air compressor. Also see the next entry.

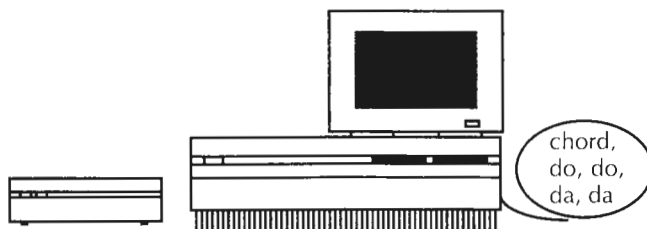
Symptoms: On startup, the normal startup chime is *quickly* followed by an error chord, then a *do-do-da-da* sound. The internal hard drive doesn't make its usual noises. The disk drive doesn't pulse. Raster never comes up on the monitor(s).

Typical history: The problem occurred right after you installed an external SCSI hard drive.

Probable diagnosis: The SCSI cable isn't plugged all the way into the 50-pin connector on the back of the external hard drive.

Solution: Check the SCSI cable. Make sure both ends are plugged all the way in. Make sure that the screws are tightened and make sure the bails are fastened. Also see the prior entry.

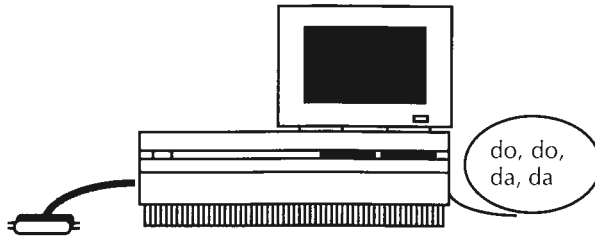
Symptoms: On startup, you get the normal startup chime, the hard drive (if present) makes its usual noises, the raster starts to come up on the monitor, the disk drive pulses as usual and then (right about when the *Welcome to Macintosh* dialog box should appear) you get a *do-do-da-da* sound and the raster blacks out.

Typical history: The problem occurred right after you disconnected/removed the last SCSI device on the bus, but not the cable.

Probable diagnosis: There's a termination problem on the SCSI bus.

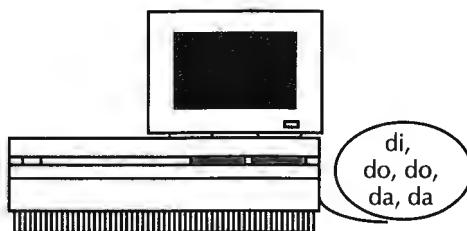
Symptoms: On startup, you get the normal startup chime, then you get a single high note followed by a *do-do-da-da* sound and then the raster blacks out.

Typical history: The problem occurred when (or shortly after) you installed a RAM upgrade.

Probable diagnosis: The problem is on the logic board.

Solution: Check/replace the four SIMMs located in bank A.

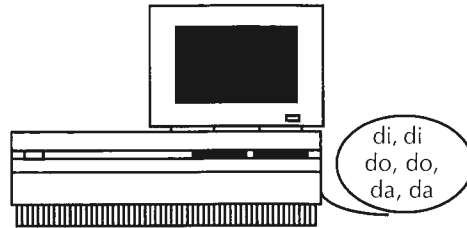
Symptoms: On startup, you get the normal startup chime, then you get a high note, followed by an even higher note, followed by a *do-do-da-da* sound. Then the raster blacks out.

Typical history: The problem occurred when (or shortly after) you installed a RAM upgrade.

Probable diagnosis: The problem is on the logic board.

Solution: Check/replace the four SIMMs located in bank B.

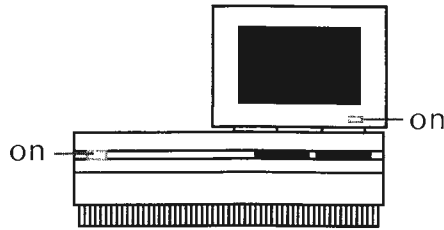
Symptoms: On powerup, the green power supply light comes on, but the normal startup chime doesn't sound. Raster never comes up on the monitor.

Probable diagnosis: The problem is on the Macintosh II logic board.

Solution: Check/replace the HMMU located at board reference U67 on the 820-0163-03 logic board and grid reference UG13 on the 820-0228-A logic board. If the black chip is spotted or shows signs of overheating, replace it with an MC68851RC16A PMMU (paged memory management unit). Also see the next entry.

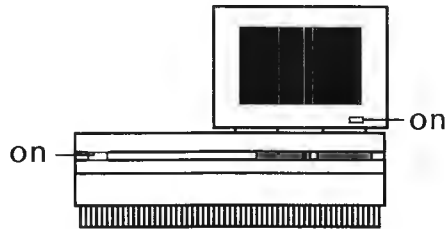
Symptoms: On powerup, the green power supply light comes on, but the normal startup chime doesn't sound. Raster never comes up on the monitor.

Typical history: The problem occurred when (or shortly after) you installed a PMMU upgrade.

Probable diagnosis: The problem is on the logic board. The PMMU is probably loose in the socket.

Solution: Check/replace the PMMU located at board reference U67 on the 820-0163-03 logic board and grid reference UG13 on the 820-0228-A logic board.

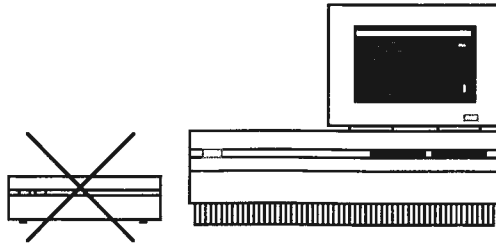
Symptoms: The internal hard drive works OK, but external hard drives (that work perfectly on other Macs) don't work on this machine.

Typical history: The problem occurred when you plugged a parallel printer into the SCSI port.

Probable diagnosis: The problem is on the logic board.

Solution: Check/replace the fuse (1A, Pico) at board reference F1. Also see the next entry.

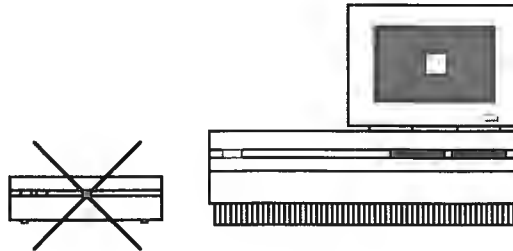
Symptoms: Internal and external hard drives (that work perfectly on other Macs) don't work on this machine.

Typical history: The problem occurred after you connected or disconnected a SCSI cable while the power was on.

Probable diagnosis: The problem is on the Mac II logic board.

Solution: Check/replace the SCSI chip (53C80-P44, SMD) at board reference U45 on the 820-0163-03 logic board and grid reference B8 on the 820-0228-A logic board. Also see the prior entry.

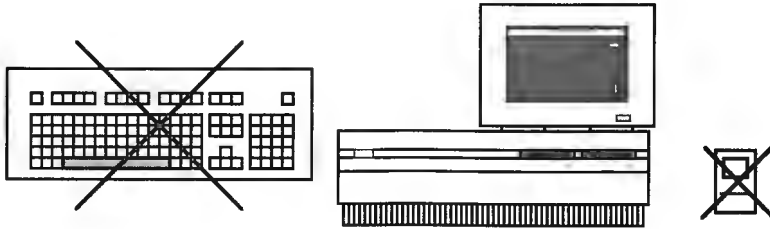
Symptoms: On startup, the desktop appears, but neither the keyboard nor the mouse works.

Typical history: The problem occurred after you connected or disconnected an ADB device while the computer was on.

Probable diagnosis: The problem is on the Mac II logic board.

Solution: Check/replace the fuse (1A, Pico) at board reference F2. Also see the next entry.

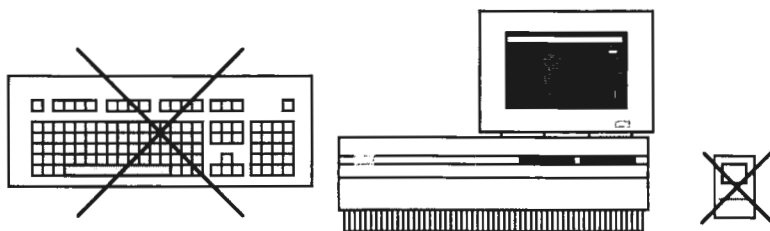
Symptoms: On startup, the desktop appears, but neither the keyboard nor the mouse works.

Typical history: The problem occurred after you connected or disconnected an ADB device while the computer was on.

Probable diagnosis: The problem is on the Mac II logic board.

Solution: Check/replace the shorted filter (Apple part 155-0007-E) at location L7 on the 820-0163-03 logic board and grid reference A14 on the 820-0228-A logic board. Also see the prior entry.

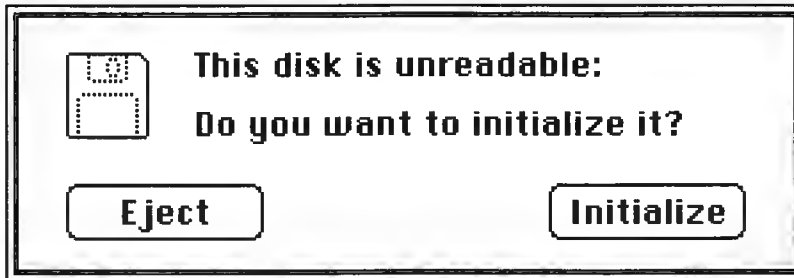
Symptoms: Regardless of which disk you insert, the computer says, *This disk is unreadable: Do you want to initialize it?*

Typical history: The problem started out of the blue (not right after a stuck disk was yanked out with pliers).

Probable diagnosis: The 400K read/write head is dirty.

Solution: Clean the read/write head with a *single-sided* cleaning diskette, preferably moistened with isopropyl alcohol. If that doesn't do it, see the prior entry.

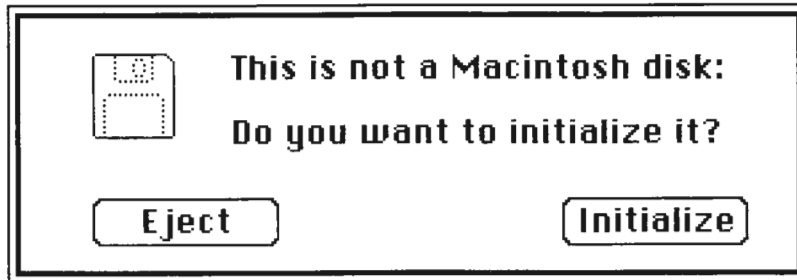
Symptoms: Regardless of which disk you insert, the computer says *This is not a Macintosh disk: Do you want to initialize it?*

Typical history: The same 400K disks work fine in other drives.

Probable diagnosis: The stepper motor is out of alignment.

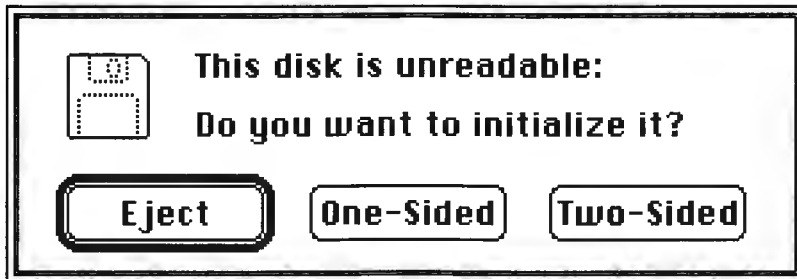
Symptoms: Regardless of which disk you insert, the computer says, *This disk is unreadable: Do you want to initialize it?*

Typical history: The problem started right after a stuck disk was forcibly ejected from the drive (yanked out with pliers).

Probable diagnosis: During the forcible eject, the open disk shutter dislocated the upper read/write head.

Solution: Replace the 800K read/write head assembly (Sony part A-8010-223-A). If necessary, perform the track zero alignment procedure described starting on page 274.

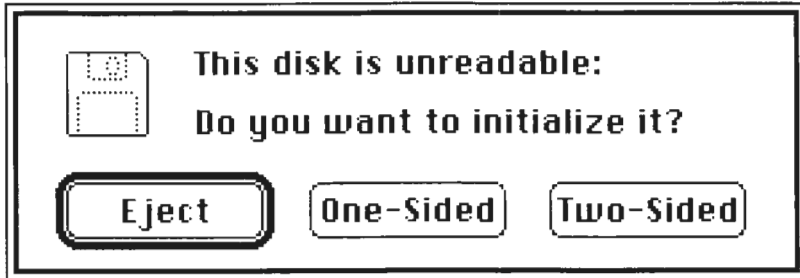
Symptoms: Regardless of which disk you insert, the computer says, *This disk is unreadable: Do you want to initialize it?*

Typical history: The problem started out of the blue (not right after a stuck disk was yanked out with pliers).

Probable diagnosis: The read/write head is dirty.

Solution: Clean the read/write head with a *double-sided* cleaning diskette, preferably moistened with isopropyl alcohol. Also see the next entry.

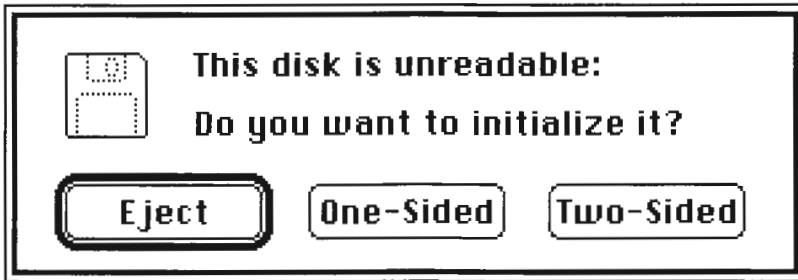
Symptoms: Regardless of which disk you insert, the computer says, *This disk is unreadable: Do you want to initialize it?*

Typical history: The problem started during a heat wave (90° to 100°) after the drive had been in use for several hours.

Probable diagnosis: The drive got too hot to continue working.

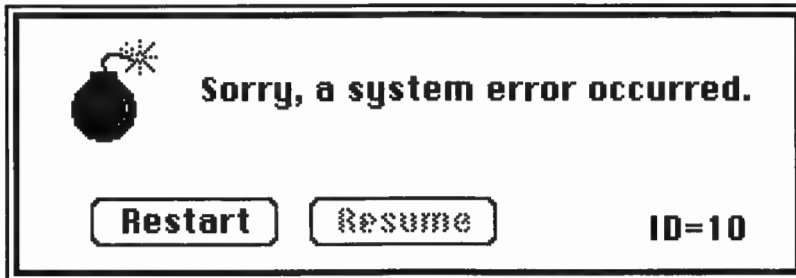
Symptoms: Regardless of what program you happen to be running, you intermittently get a dialog stating, *Sorry, a system error occurred. ID=10.*

Typical history: The problem generally occurs in warm weather, or after the drive has been in use for several hours, when you choose *Open, Save, Quit* or some other menu item.

Probable diagnosis: The drive got too hot to continue working.

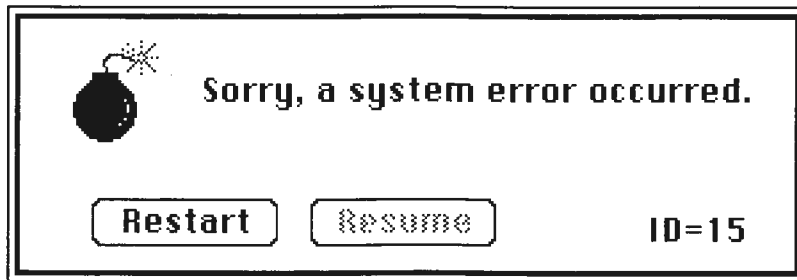
Symptoms: Regardless of what program you happen to be running, you intermittently get a dialog stating, *Sorry, a system error occurred. ID=15*

Typical history: The problem generally occurs in warm weather, or after the drive has been in use for several hours, when you choose *Open, Save, Quit* or some other menu item.

Probable diagnosis: The drive got too hot to continue working.

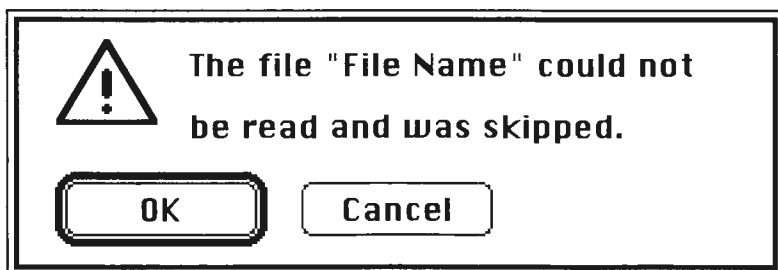
Symptoms: When copying files from 800K disks, you get a dialog box stating, *The file "File Name" could not be read and was skipped*; but when copying files from 400K disks, everything works perfectly.

Typical history: The problem developed gradually, in combination with an eject problem.

Probable diagnosis: The upper head assembly is bent. There's not enough pressure on the top side of the disk.

Solution: Replace the 800K read/write head assembly (Sony part A-8010223-A). If necessary, perform the track zero alignment procedure (see page 274).

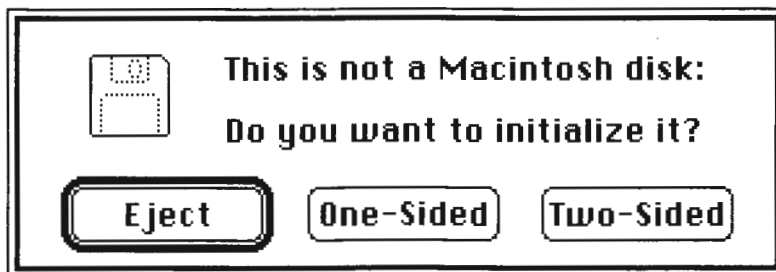
Symptoms: Regardless of which 800K disk you insert, the computer says, *This is not a Macintosh disk: Do you want to initialize it?*; but 400K disks read/write perfectly.

Typical history: The problem developed together with an eject problem. The same 800K disks work fine in other drives.

Probable diagnosis: The upper read/write head is bent. It's no longer in contact with the top side of the disk.

Solution: Replace the 800K read/write head assembly (Sony part A-8010223-A). If necessary, perform the track zero alignment procedure (see page 274).

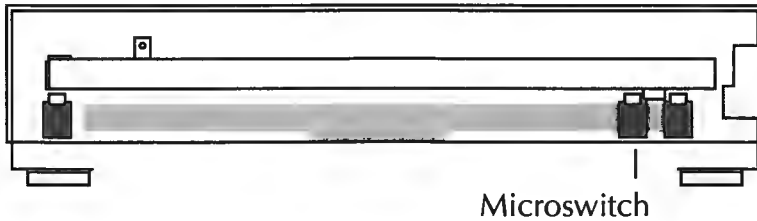
Probable diagnosis: One of the microswitches is sticky.

Solution: Lubricate the sticky microswitch with WD-40.

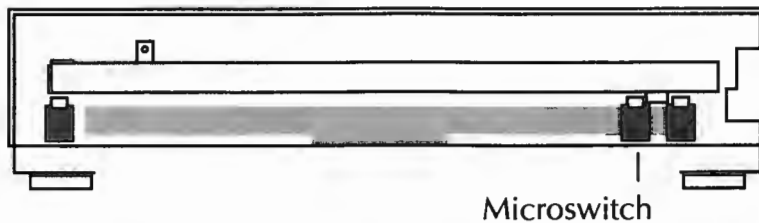
Probable diagnosis: One of the microswitches is sticky.

Solution: Lubricate the sticky microswitch with WD-40.

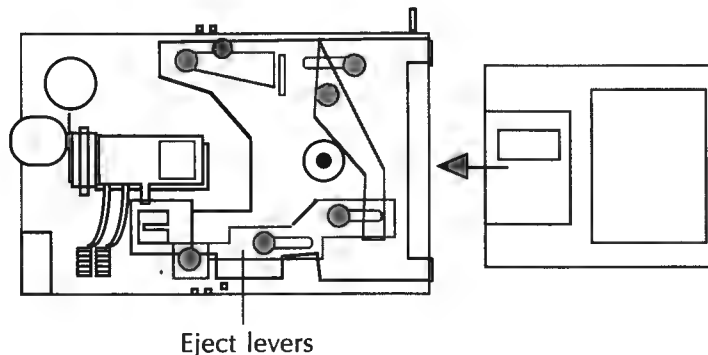
Probable diagnosis: The OEM grease used on the eject levers has dried out and turned to glue.

Solution: Remove the sticky dried-out grease with paper towels and cotton swabs. Relubricate the eject levers with WD-40. To remove a stuck disk from the drive (without damaging the heads), see the disassembly instructions at the end of this chapter.

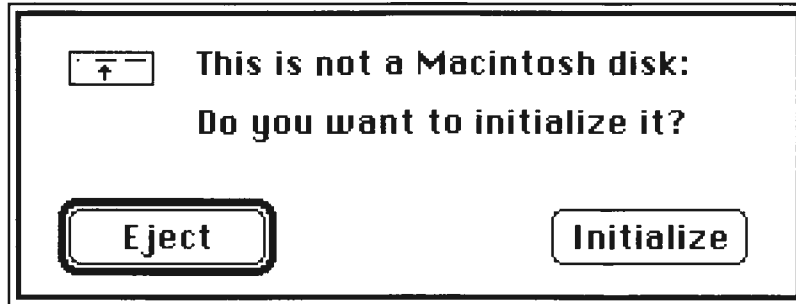
Symptoms: Regardless of which 1.4MB or 800K disk you insert, the computer says, *This is not a Macintosh disk: Do you want to initialize it?*; but 400K disks work perfectly.

Typical history: The problem developed suddenly, in combination with an eject problem.

Probable diagnosis: The upper head assembly is bent. It's no longer in contact with the top side of the disk.

Solution: Replace the 1.4MB read/write head assembly (Sony part A-8010-251-A). If necessary, perform the track zero alignment procedure.

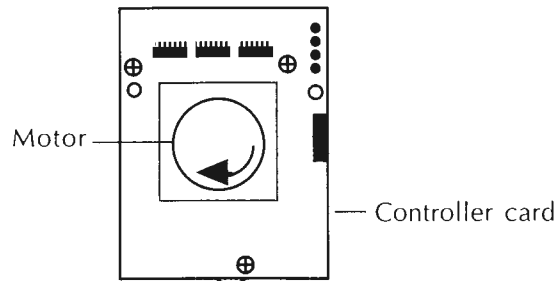
Symptoms: On startup, the disk access light (not visible on a Mac II) comes on and stays on, but the drive does not spin. If the computer isn't shut off immediately, the drive gets very hot and you smell burning grease.

Probable diagnosis: The hard disks are stuck. Either there's too much resistance on the drive bearing, or one of the heads is stuck to the media.

Solution: Fold back the embedded controller card and spin the motor (to get it started) by hand. Nine times out of ten, once you put the controller card back on, the drive will work fine, for an indefinite period of time.

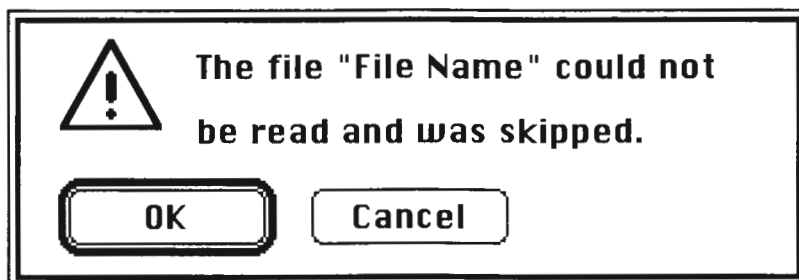
Symptoms: When copying files you get a dialog box stating, *The file "File Name" could not be read and was skipped.*

Typical history: The problem started right after the drive was optimized or updated using a generic SCSI utility.

Probable diagnosis: The updated SCSI driver (using blind reads and writes) is incompatible with this drive (which requires handshaking).

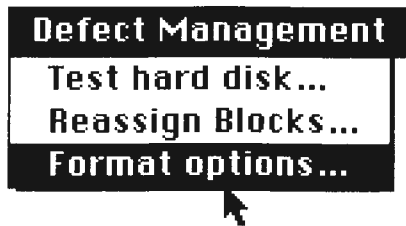
Probable diagnosis: The OEM SCSI driver has been corrupted.

Solution: Reformat the drive with DiskManager Mac version 2.24 by choosing *Format options...* from the Defect Management menu and selecting *Use manufacturer's default format* from the dialog box.

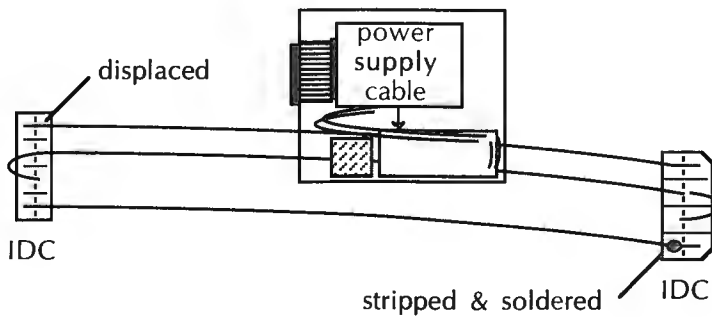
Probable diagnosis: One of the insulation displacement connectors (IDCs) on the power supply cable is intermittent.

Solution: Strip and solder *both* ends of *each* wire to the insulation displacement connectors.

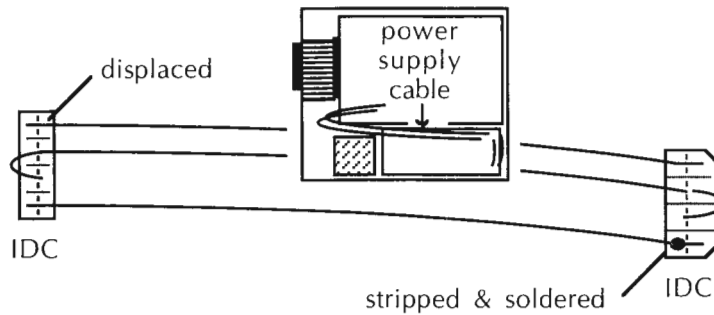
Probable diagnosis: One of the insulation displacement connectors (IDCs) on the power supply cable is intermittent.

Solution: Strip and solder *both* ends of *each* wire to the insulation displacement connectors.

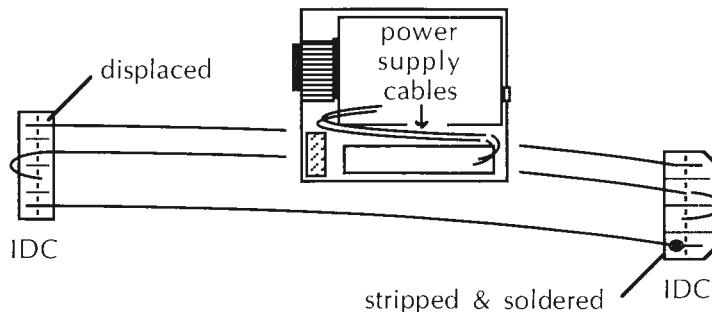
Probable diagnosis: One of the insulation displacement connectors (IDCs) on one of the *two* power supply cables is intermittent.

Solution: Strip and solder *both* ends of *each* wire to the insulation displacement connectors on *both* power supply cables. (Only one of the two cables is shown in the diagram.)

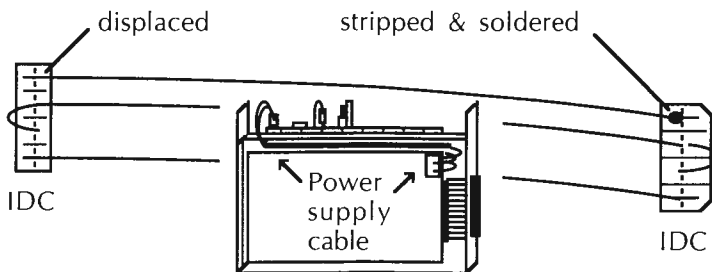
Probable diagnosis: One of the insulation displacement connectors (IDCs) on the power supply cable is intermittent.

Solution: Strip and solder *both* ends of *each* wire to the insulation displacement connectors.

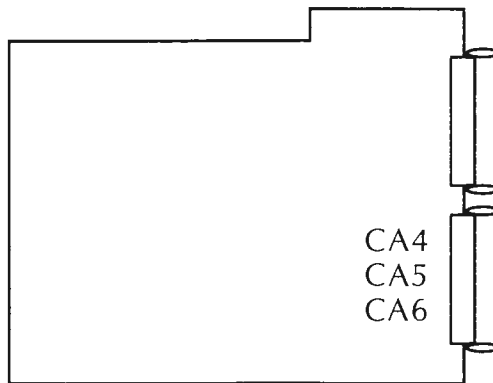
Probable diagnosis: The problem is on the Apple Scanner logic board.

Solution: Break off the filter networks at board locations CA4, CA5 and CA6. No replacements are necessary.

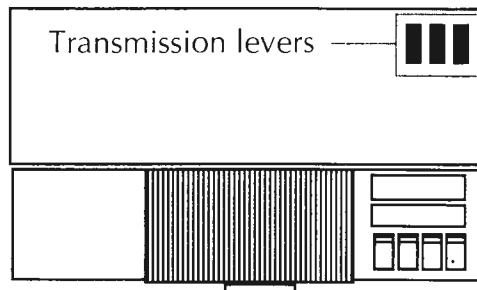
Probable diagnosis: The problem is in the printer mechanism.

Solution: Check/resynchronize the transmission levers (located under the top cover assembly).

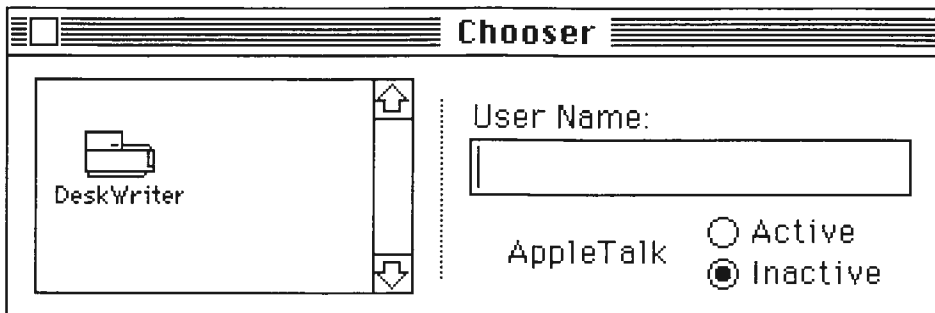
Probable diagnosis: The DeskWriter is connected to the printer port and AppleTalk is turned on, but the DeskWriter is connected via a serial cable (not connected via a LocalTalk cable).

Solution: Open the Chooser DA and deactivate AppleTalk.

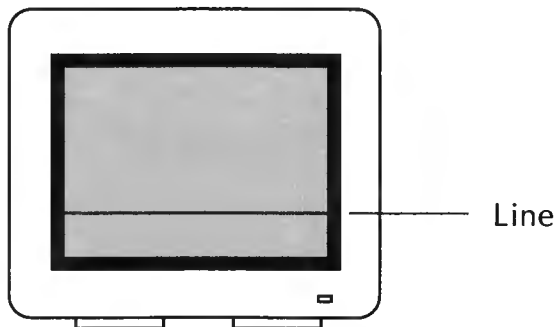
Symptoms: There's a thin horizontal line located about 2¼ inches up from the bottom of the screen. The thin line is stationary. It never goes away. It's visible in all programs.

Probable diagnosis: The thin line is a characteristic of the particular Trinitron CRT (Sony part M34JNQ10X) used in this monitor. There's nothing to be done about it.

Solution: Ignore the line or switch to a different brand of monitor.

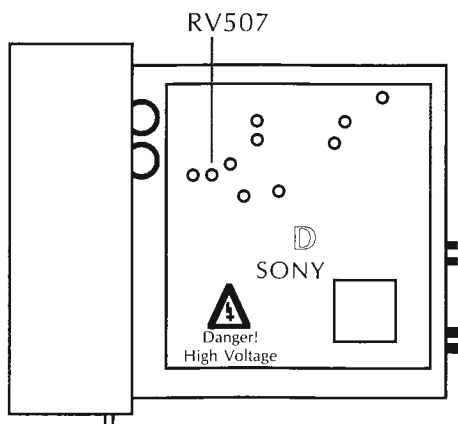
Probable diagnosis: The problem is on the D board.

Solution: Carefully adjust variable resistor RV507, labeled *V.HOLD*, counterclockwise for a stable picture. A *very slight* turn is generally all that's required.

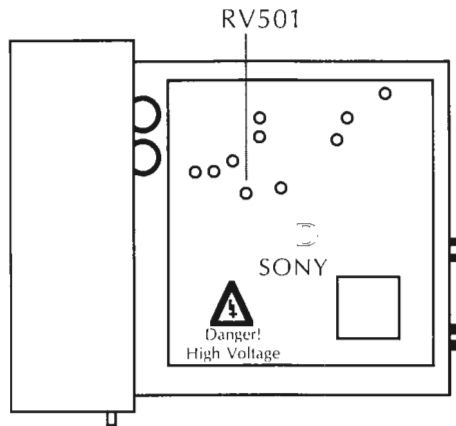
Probable diagnosis: The problem is on the D board.

Solution: Carefully turn variable resistor RV501, labeled *H.HOLD*, counterclockwise until the left side of the display unfolds.

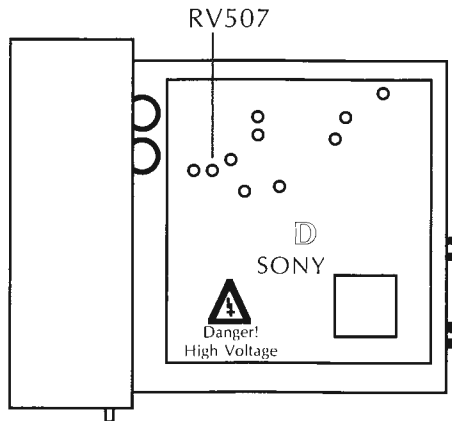
Probable diagnosis: The problem is on the D board.

Solution: Carefully turn variable resistor RV507, labeled *V.HOLD*, counterclockwise for a stable picture. A *very slight* turn is generally all that's required. Also see the next entry.

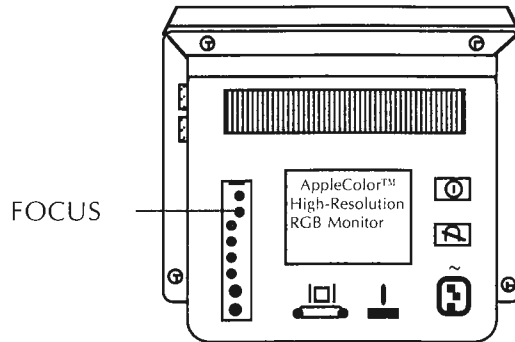
Probable diagnosis: The problem is on the H board, located under the control cover plate at the back of the monitor.

Solution: Carefully adjust the variable resistor RV 701, labeled *FOCUS*, for a sharp, clear picture. Also see the next entry.

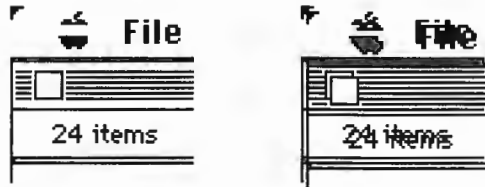
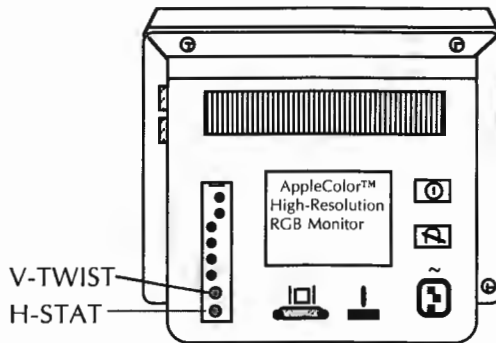
Symptoms: The display is covered with red, green or blue shadows. In extreme cases, it may resemble a 3-D comic book as seen without the special eyeglasses.

Probable diagnosis: The problem is on the H board, located under the control cover plate at the back of the monitor.

Solution: Carefully adjust the variable resistors labeled *V-TWIST* and *H-STAT*, until the colored shadows disappear.

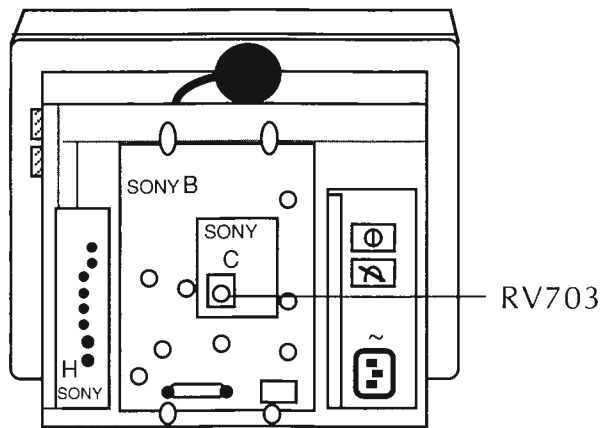
Probable diagnosis: The problem is on the C board.

Solution: Carefully adjust variable resistor RV703, labeled *H-STAT*, until the blue shadows disappear.

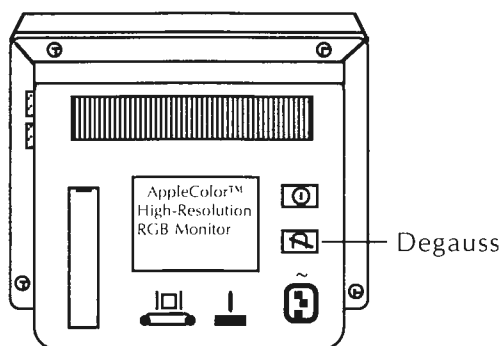
Probable diagnosis: Moving the monitor without turning off the power magnetized the CRT.

Solution: Demagnetize the CRT by pressing the degauss switch.

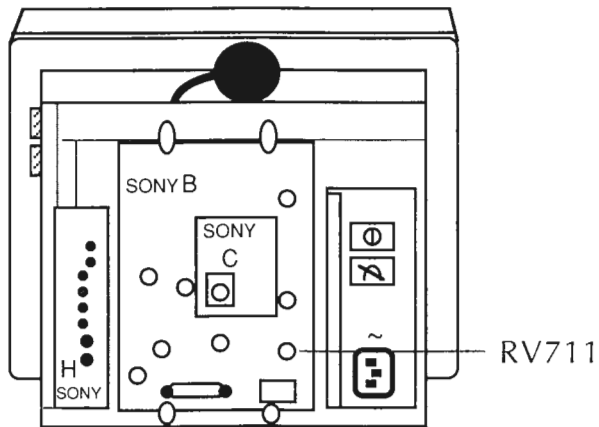
Probable diagnosis: The problem is on the B board.

Solution: Carefully adjust variable resistor RV711, labeled *R.BKG*, clockwise until the red tint just disappears. A *very slight* clockwise turn is generally all that's required.

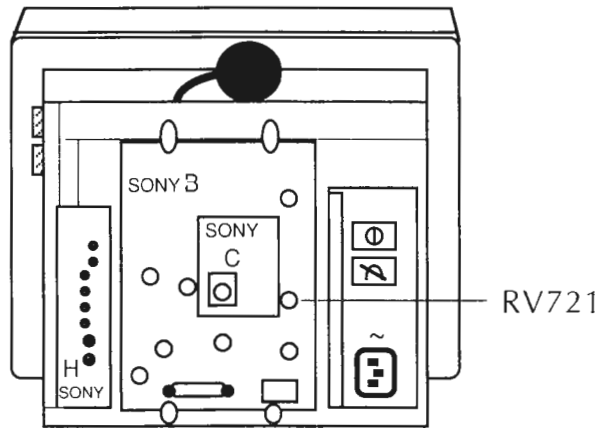
Probable diagnosis: The problem is on the B board.

Solution: Carefully adjust variable resistor RV721, labeled *G.BKG*, clockwise until the green tint just disappears. A *very slight* clockwise turn is generally all that's required.

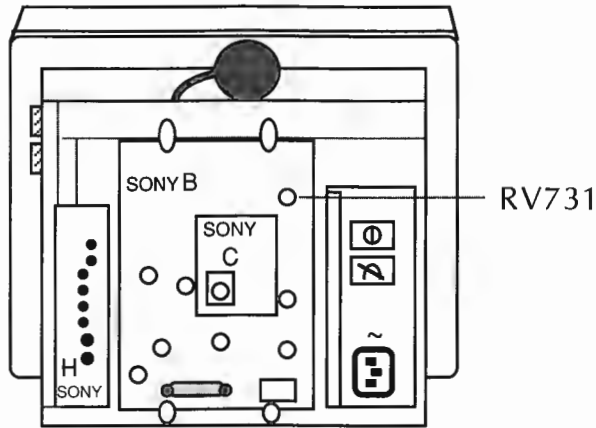
Probable diagnosis: The problem is on the B board.

Solution: Carefully adjust variable resistor RV731, labeled *B.BKG*, clockwise until the blue tint just disappears. A *very slight* clockwise turn is generally all that's required.

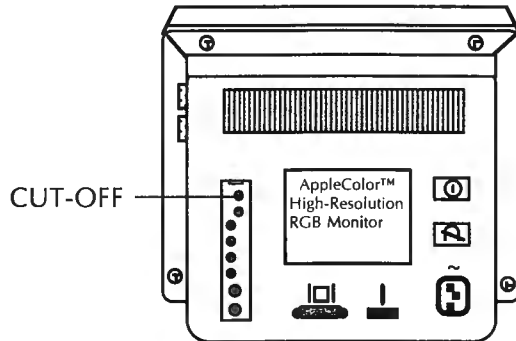
Probable diagnosis: The problem is on the H board, located under the control cover plate at the back of the monitor.

Solution: Carefully turn variable resistor RV 702, labeled *CUT-OFF*, counterclockwise for a darker picture. If this fails to solve the problem, see the next entry.
