THE MACINTOSH
BIBLE GUIDE
TO SAVING A FORTUNE
ON MAC REPAIRS

THE DEAD MAC SCROLLS

HOW TO FIX HUNDREDS
OF HARDWARE PROBLEMS
WITHOUT GOING BANKRUPT

LARRY PINA

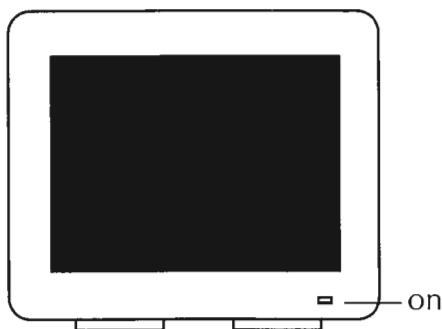
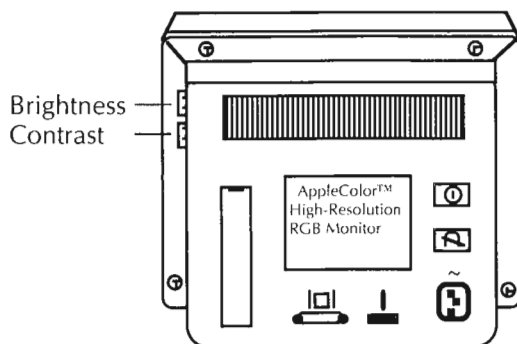
Symptoms: On powerup, the monitor clicks and the green light comes on, but there's no video.

Probable diagnosis: The brightness and contrast controls (located on the right side of the cabinet) have been inadvertently turned down.

Solution: Adjust the brightness and contrast controls. If that's not it, see the next entry.

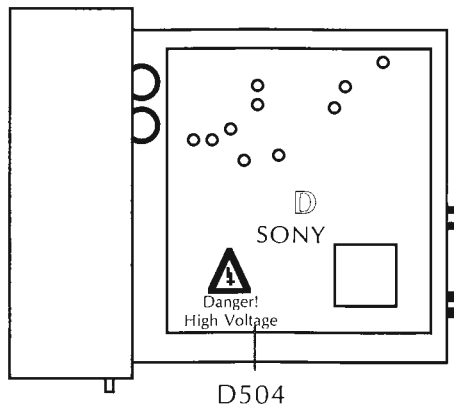
Probable diagnosis: The problem is on the D board.

Solution: Check/replace the HZ3983 zener diode (39V) at board reference D504.

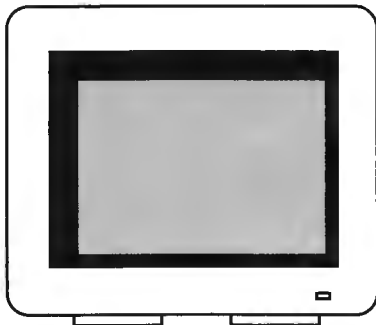
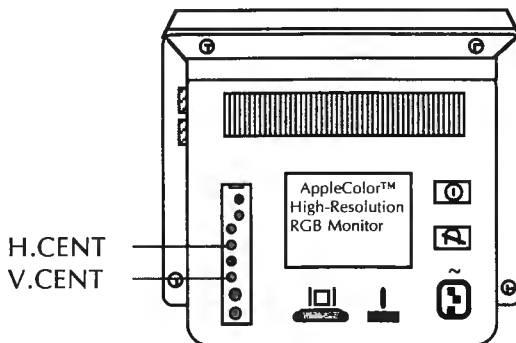
Symptoms: The display is noticeably off center. Otherwise, the monitor seems OK.

Probable diagnosis: The problem is on the H board.

Solution: Carefully turn the variable resistors labeled *H.CENT* and *V.CENT* until the display is centered on the screen.

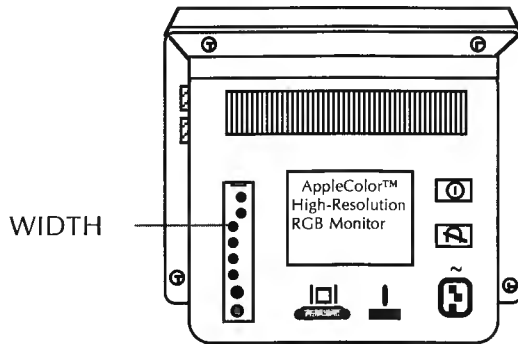
Probable diagnosis: The problem is on the H board.

Solution: To restore the factory specified width based on 640 x 480 at 69 ppi, carefully turn the variable resistor labeled *WIDTH* until the display measures 9.28 inches wide.

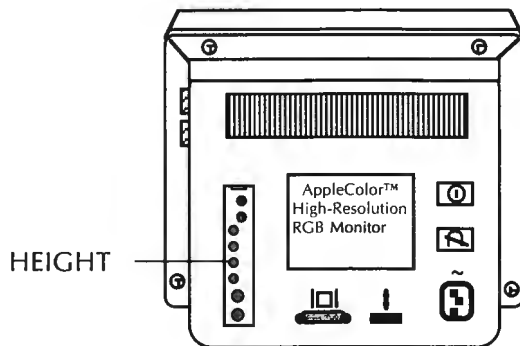
Probable diagnosis: The problem is on the H board.

Solution: To restore the factory specified height based on 640 x 480 at 69 ppi, carefully turn the variable resistor labeled *HEIGHT* until the display measures 6.96 inches high.

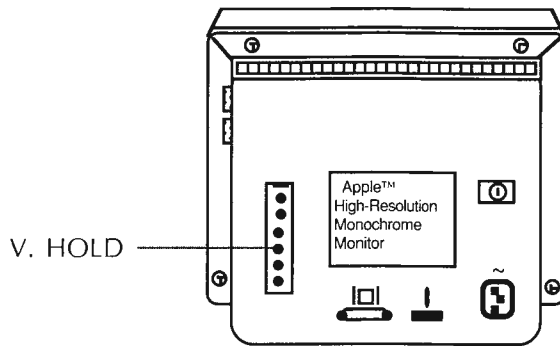
Probable diagnosis: The problem is on the H board, located under the control cover plate at the back of the monitor.

Solution: Carefully adjust the variable resistor labeled *V.HOLD* for a stable picture.

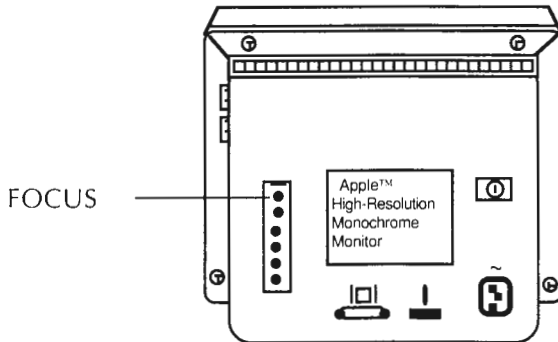
Probable diagnosis: The problem is on the H board, located under the control cover plate at the back of the monitor.

Solution: Carefully adjust the variable resistor, labeled *FOCUS*, for a sharp, clear picture.

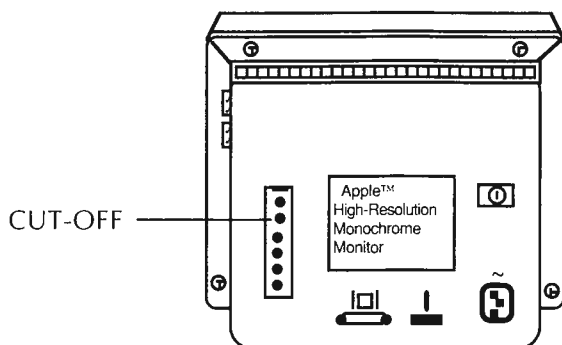
Probable diagnosis: The problem is on the H board, located under the control cover plate at the back of the monitor.

Solution: Carefully turn the variable resistor labeled *CUT-OFF* counterclockwise for a darker picture.

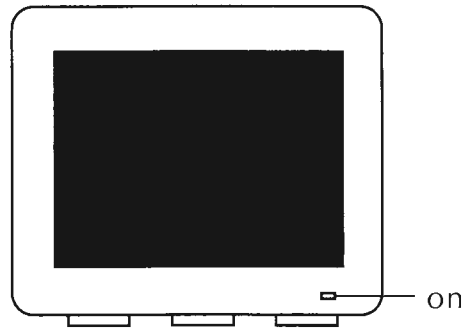
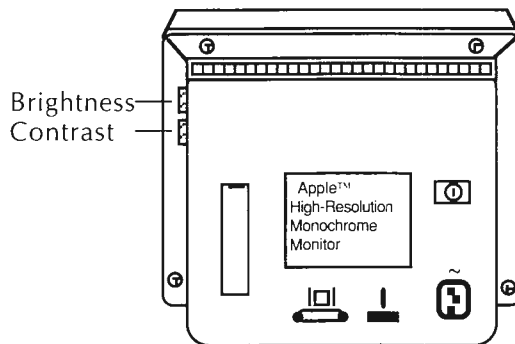
Symptoms: On powerup, the monitor clicks and the green light comes on, but there's no video.

Probable diagnosis: The brightness and contrast controls (located on the right side of the cabinet) have been inadvertently turned down.

Solution: Adjust the brightness and contrast controls.

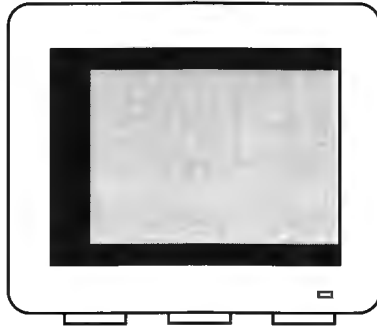
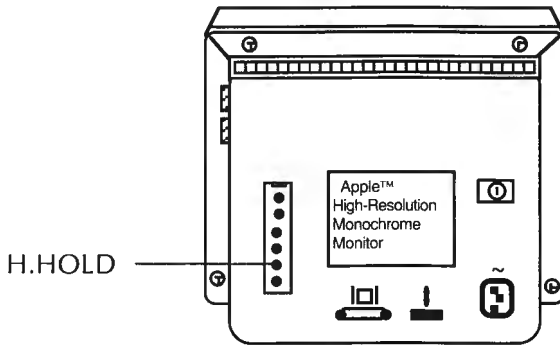
Symptoms: The display is noticeably off center. Otherwise, the monitor seems OK.

Probable diagnosis: The problem is on the H board.

Solution: Carefully turn the variable resistor labeled *H.HOLD* until the display is centered on the screen.

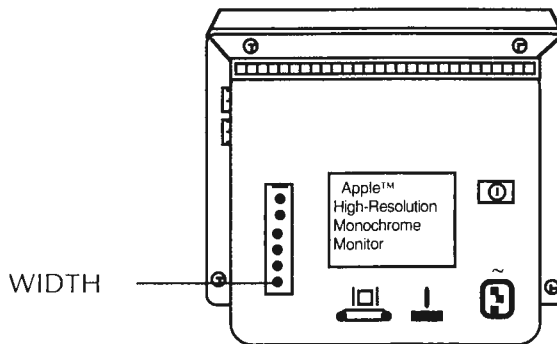
Probable diagnosis: The problem is on the H board.

Solution: To restore the factory specified width and appearance based on 640 x 480 at 76 ppi, carefully turn the variable resistor labeled *WIDTH* until the display measures 8.42 inches wide. Also see the next entry.

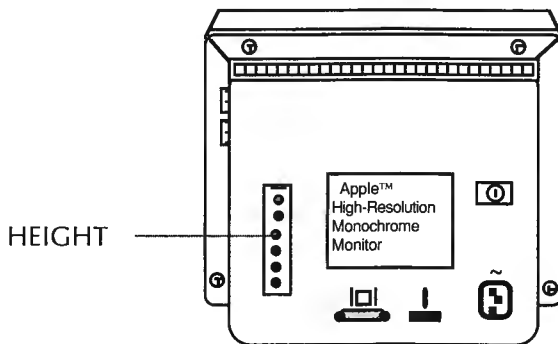
Probable diagnosis: The problem is on the H board, located under the control cover plate at the back of the monitor.

Solution: To restore the factory specified height based on 640 x 480 at 76 ppi, carefully turn the variable resistor labeled *HEIGHT* until the display measures 6.32 inches wide. Also see the prior entry.

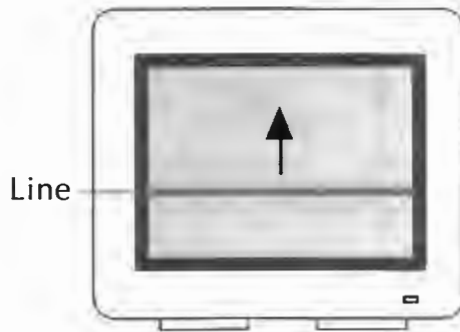
Symptoms: There is a black line rippling through the display on the external monitor.

Probable diagnosis: Radio frequency interference (RFI) emanating from the Macintosh analog board (located on the left side of the Mac's cabinet) is causing the line.

Solution: Relocate the external monitor to the right of the Macintosh. If the rippling line persists, separate the two by an additional twelve to eighteen inches.

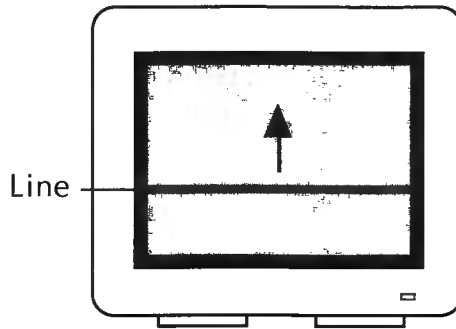
Symptoms: There is a black line rippling through the display on one or both of the monitors.

Probable diagnosis: Radio frequency interference (RFI) emanating from one or both of the monitors is causing the line(s).

Solution: Reverse the location of the monitors. If the rippling persists, separate the two by an additional twelve to eighteen inches.

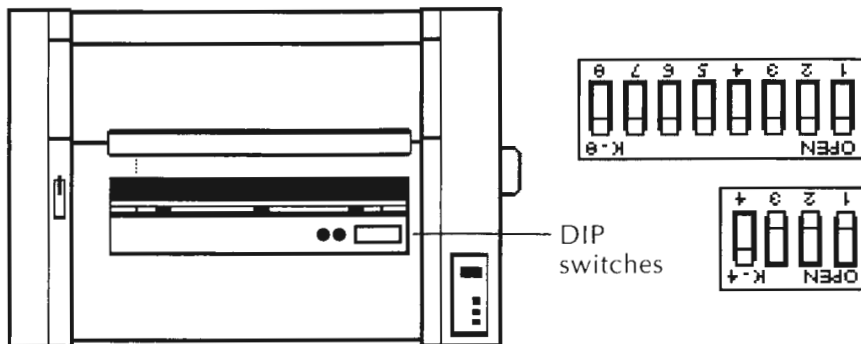
Probable diagnosis: The DIP switches are incorrectly set for all-around Mac use.

Solution: Position the DIP switches inside the ImageWriter exactly as shown. If that doesn't do it, see the next entry.

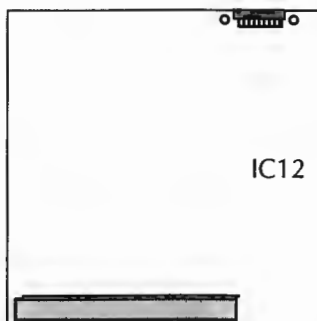
Probable diagnosis: The problem is on the ImageWriter logic board.

Solution: Replace the 74LS393N IC (14-pin DIP, dual 4-bit binary ripple counter) at board reference IC12. Also see the prior entry.

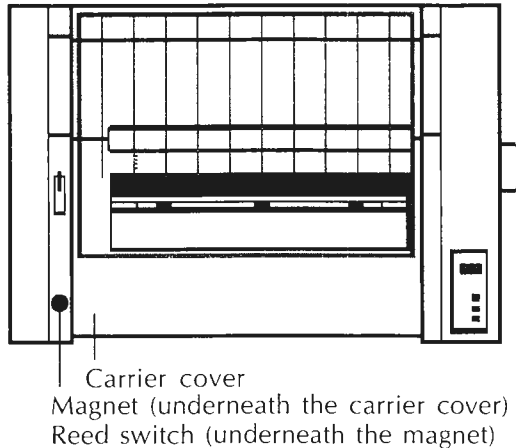
Symptoms: The Select lamp *does not* light, the printer *does not* respond to *Print...* commands and the built-in self-test *does not* work.

Probable diagnosis: The carrier cover is incorrectly positioned, or the safety magnet (underneath the carrier cover) is missing.

Solution: Check/reposition the carrier cover. Check the safety magnet. Verify the operation of the reed switch (normally activated by the carrier cover magnet) with a small crafts magnet. If everything under the carrier cover checks OK, see the next entry.

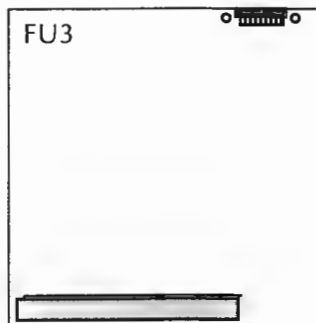
Probable diagnosis: The problem is on the ImageWriter logic board.

Solution: Check for loose metallic objects (coins, hair pins, paper clips) inside the printer. Check/replace the 5A glass fuse (AGC 5) at board reference FU3. If that still doesn't do it, see the next entry.

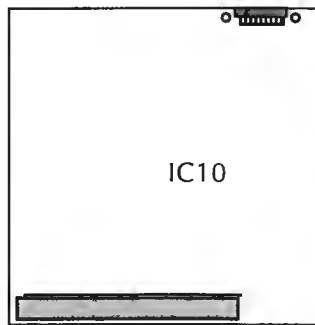
Symptoms: The Select lamp *does not* light, the printer *does not* respond to *Print...* commands. The built-in self-test *does not* work.

Probable diagnosis: The problem is on the ImageWriter logic board.

Solution: Check/replace the 8085A-2 IC (40-pin CPU, 8-bit, N-channel, 5MHz) at board reference IC10. Also see the prior entry.

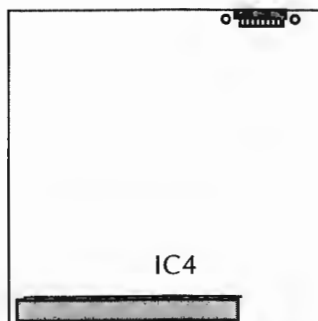
Symptoms: The Select lamp *does* light and the printer responds to *Print...* commands, but there is no line feed. The carrier motor works, the typehead fires and the ribbon deck goes back and forth, but every line prints on top of the prior line. The Form Feed button *does* work, but the Line Feed button *does not* work. Except for the line-feed problem, the built-in self-test also works.

Probable diagnosis: The problem is on the ImageWriter logic board.

Solution: Check/replace the SN 7406 IC (14-pin DIP, hex inverter buffer/driver, open collector, high voltage) at board reference IC4.

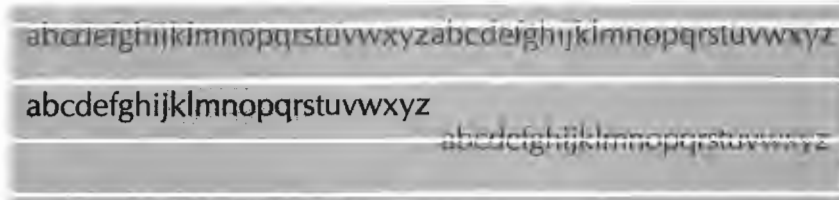
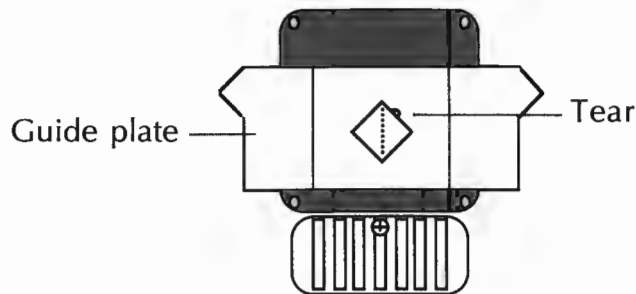
Symptoms: The ribbon cartridge deck makes a scraping noise as it moves from side to side. Printed pages contain regularly spaced horizontal scratch marks (even in the white spaces).

Probable diagnosis: The ribbon guide plate (on the typehead) is torn. A metal hangnail is catching on the paper stock.

Solution: Replace the ribbon guide plate (C. Itoh CLA20-13801).

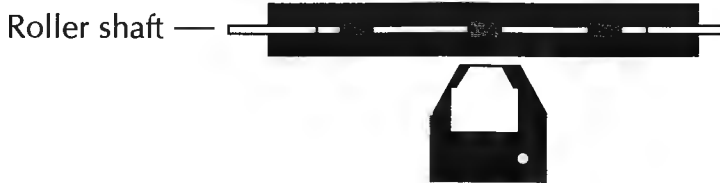
Symptoms: The first line printed on every page is squashed.

Probable diagnosis: The roller shaft assembly is so dry and gritty that it's causing the paper to buckle.

Solution: Clean and lubricate the roller shaft. If that doesn't do it, see the next entry.

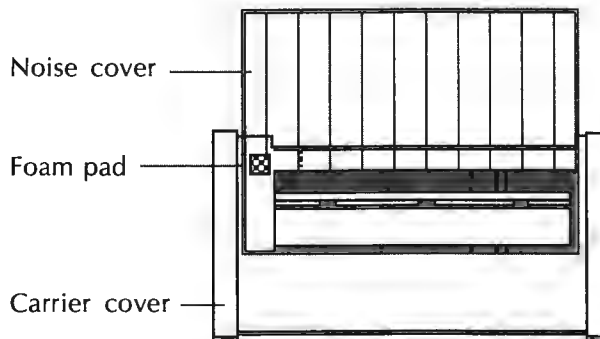
Probable diagnosis: The clear plastic noise cover is warped. The weight of the bent plastic is pressing on the paper.

Solution: Lift the weight by sticking a small foam pad between the noise cover and the carrier cover. Also see the prior entry.

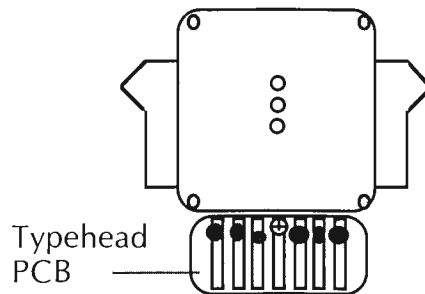
Probable diagnosis: The contacts on the typehead PCB are dirty.

Solution: Clean the contacts with a pencil eraser. If that doesn't do it, see the next entry.

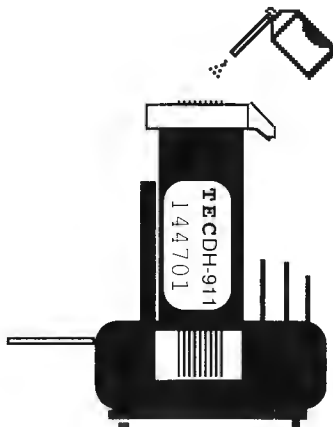
Probable diagnosis: One of the striker wires in the typehead is rusty. The wire is hanging on the plastic ribbon guide (instead of slipping through and onto the paper).

Solution: Spray the ribbon guide with a drop or two of WD-40. Let it soak in for several hours (preferably overnight) before reinstalling the typehead. If that still doesn't do it, see the next entry.

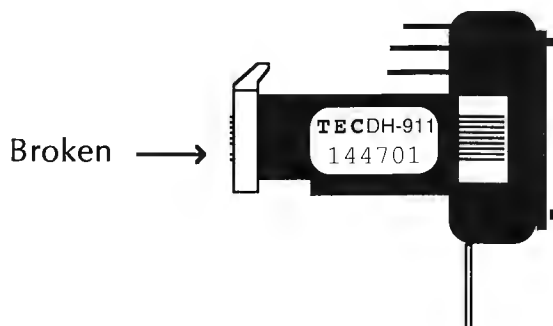
Probable diagnosis: One of the striker wires in the typehead is bent or broken, and/or one of the return springs is weak.

Solution: Send out the typehead (not the whole printer) to a service depot for repair. Also see the prior entry.

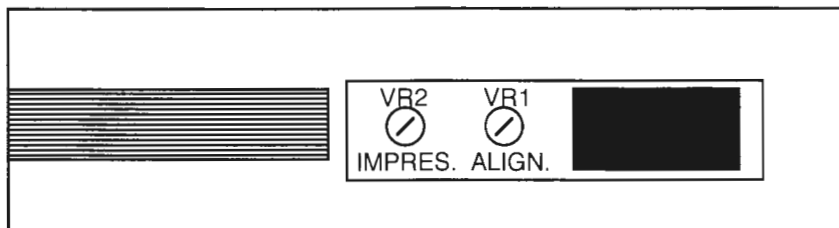
Symptoms: Best quality printing is wavy. Vertical lines are uneven.

Probable diagnosis: The character deviation is out of adjustment.

Solution: Adjust variable resistor VR1 (located under the carrier cover) for best linearity. If that doesn't do it, see the next entry.

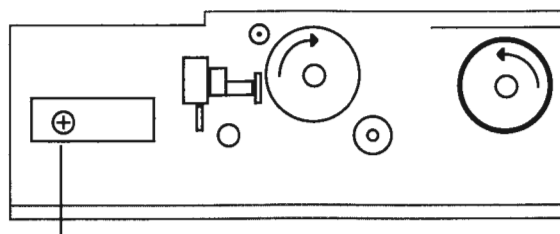
Carrier-wire tension

Probable diagnosis: The carrier-wire tension is too loose.

Solution: Adjust the carrier-wire tension lever (located under the cabinet top), then readjust VR1 (see previous entry). If that still doesn't do it, see the next entry.

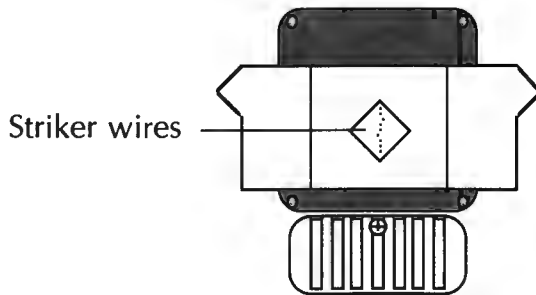
Probable diagnosis: The striker wires in the typehead are out of vertical alignment.

Solution: Send out the typehead (not the whole printer) to a service depot for repair.

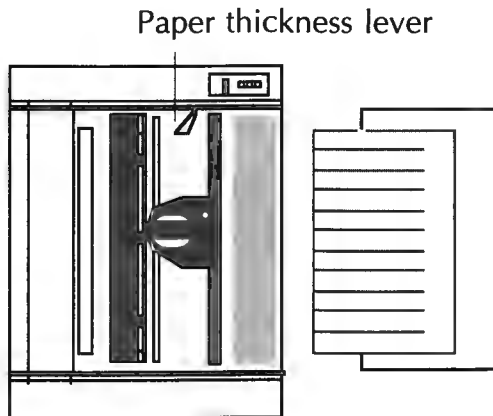
Symptoms: The printout is too light.

Probable diagnosis: The paper thickness lever is too far back.

Solution: Move the paper thickness lever closer to the platen. If that doesn't do it, see the next entry.

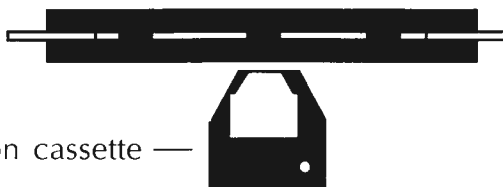
Ribbon cassette —

Probable diagnosis: The ribbon cassette is dry or worn out. (Many ImageWriters are still equipped with their original ribbons!)

Solution: Replace the ribbon cassette, C. Itoh part CLABK-12802. Also see the prior entry.

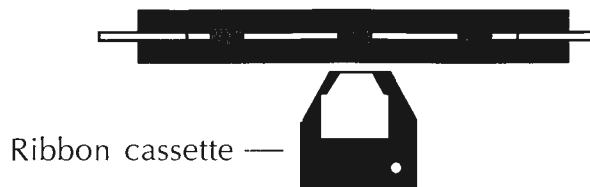
Probable diagnosis: The ribbon cassette is worn or defective.

Solution: Replace the ribbon cassette.

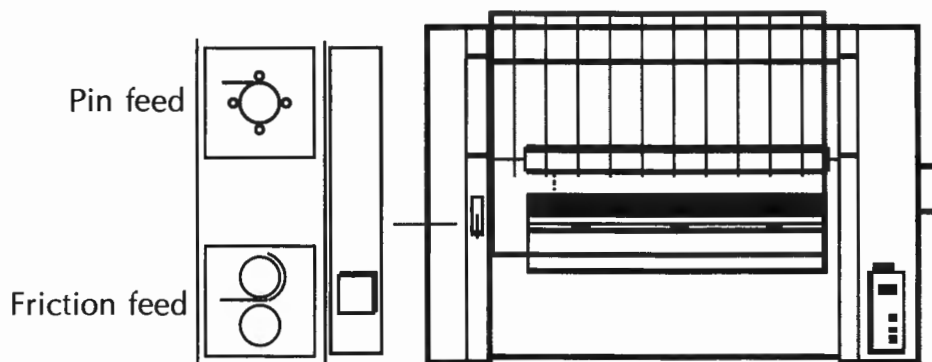
Symptoms: After a few pages, the pin-feed paper derails and the printer jams.

Probable diagnosis: The release lever is positioned for friction-feed paper (not pin-feed).

Solution: Push the release lever toward the pin-feed icon.

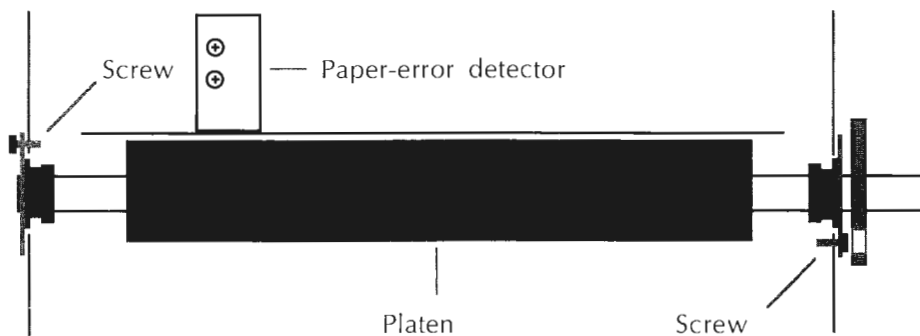
Probable diagnosis: Most likely, a mailing label is or was stuck under the platen and/or the arm on the paper-error detector is bent.

Solution: Remove the platen. Clear the label jam. Check/reposition the paper-error detector.

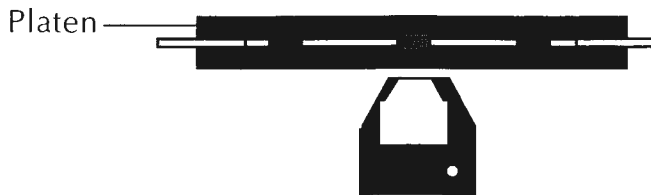
Symptoms: Cut-sheet paper slips and lines overprint in friction-feed mode.

Probable diagnosis: The platen is slipping. It's lost its grip!

Solution: Restore the platen grip with liquid tape-recorder rubber cleaner, Teac RC1 or equivalent, and a clean cotton rag.

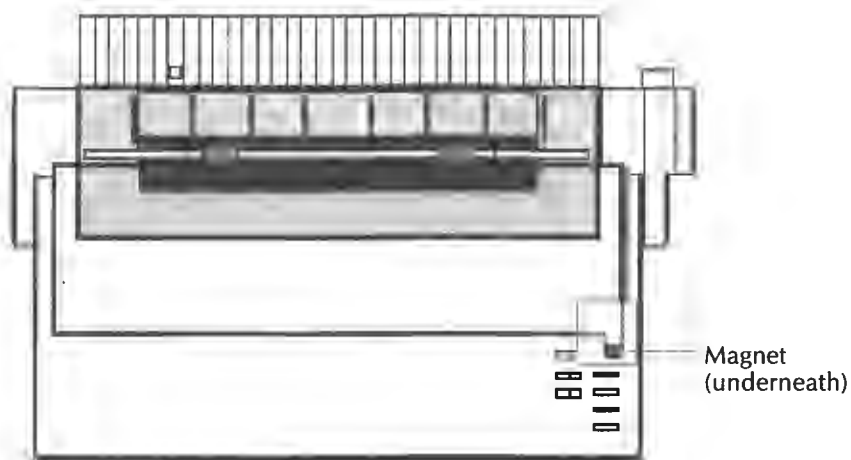
Probable diagnosis: The front cover is incorrectly positioned, or the safety magnet (underneath the front cover) is missing.

Solution: Check/reposition the front cover. Check the safety magnet. Verify the operation of the reed switch (normally activated by the front cover magnet) with a small crafts magnet. If everything under the front cover checks OK, see the next entry.

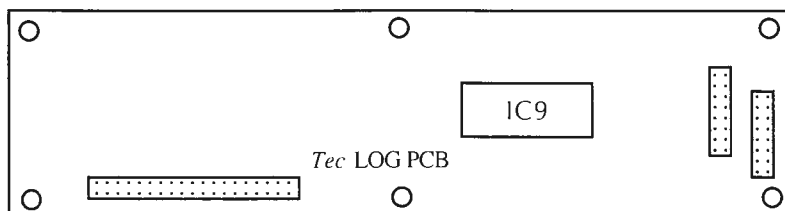
Probable diagnosis: The problem is on the ImageWriter II logic board.

Solution: Check/replace the EC-A056 IC (64-pin MOS CPU), C. Itoh part EAO-06-64300, at board reference IC9.

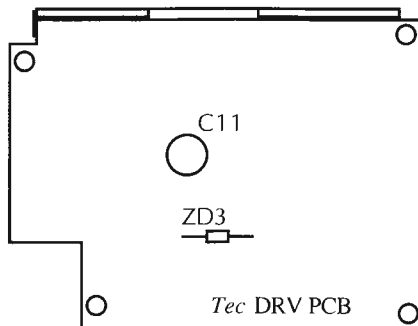
Symptoms: The Select lamp *does* light, and the unit responds to *Print...* commands, but there's no line feed. The carrier motor works, the print head fires and the ribbon cartridge deck goes back and forth, but every line prints on top of the prior line. The Form Feed button *does* work, but the Line Feed button *does not* work. Except for the line-feed problem, the built-in self-test also works.

Probable diagnosis: The problem is on the ImageWriter II driver PCB.

Solution: Check/replace the 27B1 (25V, 1W) zener diode, ECG5082A, at board reference ZD3, and check/replace the radial electrolytic capacitor (2,200 mfd, 35/44V) Digi-Key part P5262, at board reference C11. If there's still no line feed, see the next entry.

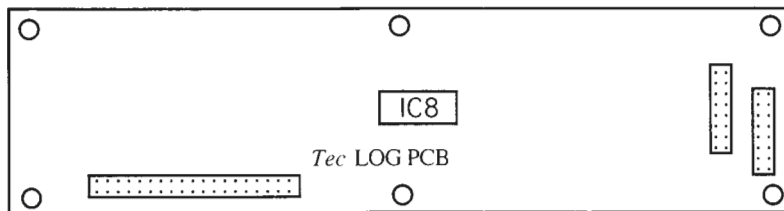
Probable diagnosis: The problem is on the ImageWriter II logic board.

Solution: Check/replace the SN 7406 IC (hex inverter buffer/driver, open collector, high voltage) at board reference IC8. Also see the prior entry.

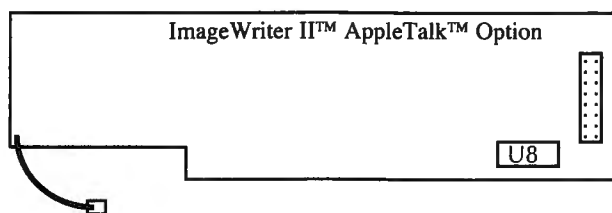
Symptoms: An ImageWriter II equipped with an AppleTalk Option Card does not show up in the Chooser or Choose Printer DA.

Probable diagnosis: The problem is on the AppleTalk Option Card (inside the ImageWriter II).

Solution: Check/replace the SN 74LS245N IC (20-pin DIP, octal bus transceiver, noninverting) at board reference U8 (on the AppleTalk Option Card inside the ImageWriter II).

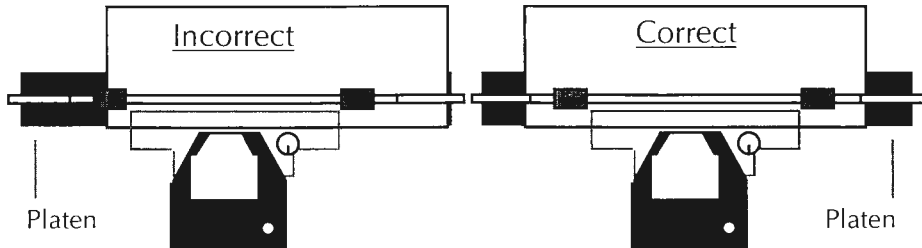
Symptoms: The red error light on the control panel is lit, even though there's paper in the printer.

Probable diagnosis: The paper is too far to the right. It's not being detected by the paper error sensor, which is located on the left side of the platen.

Solution: Move the paper to the left. Center it on the platen.

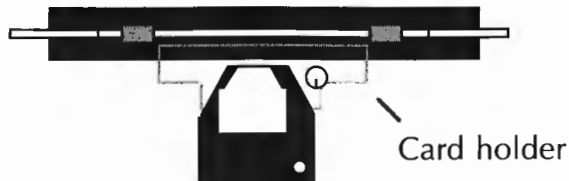
Symptoms: The ribbon carrier makes a scraping noise as it moves from side to side. Printed pages contain regularly spaced horizontal scratch marks (even in the white spaces).

Probable diagnosis: The edge of the plastic card holder (or paper guide) is melted. Beads of melted plastic are scratching the paper.

Solution: Replace the card holder (C. Itoh CQAAK-10501).

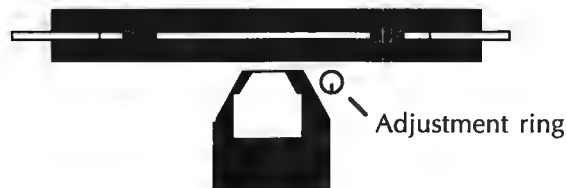
Symptoms: When a four-color ribbon is installed, cyan overlaps black at the *top* of every text character.

Probable diagnosis: The ribbon cam is out of adjustment.

Solution: Turn the adjustment ring *counterclockwise* until the colors register correctly.

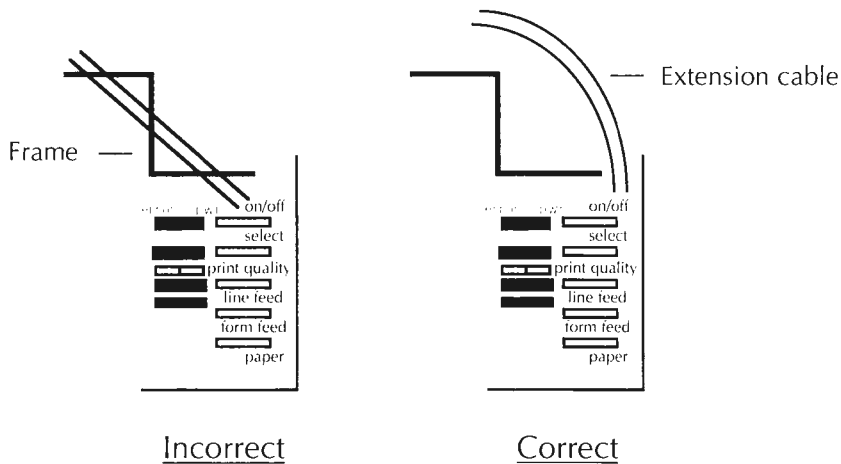
Symptoms: The on/off button on a late-model (unitized) ImageWriter II (marked *Family number: G0010; Marketing number: C0090LL/A*) is intermittent. Sometimes it works, sometimes it doesn't.

Probable diagnosis: The extension cable connecting the on/off button on the control panel to the power switch (located on the power supply/driver PCB) is pinched under the printer frame.

Solution: Reposition the extension cable as shown.

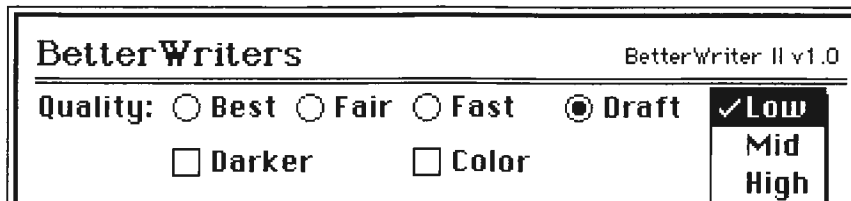
Symptoms: Whenever you select high-speed *Draft* quality, the text is printed in an ugly, 15-cpi (characters per inch) type with unacceptably large spacing between words. The same thing happens when *Best* quality is selected (printout is ugly), except the type is darker.

Probable diagnosis: The problem is in the ImageWriter resource, not in the ImageWriter II.

Solution: Replace the ImageWriter resource with the BetterWriter II driver developed by GDT Softworks. Once that's done, *Draft* and *Best* quality will both print perfectly!

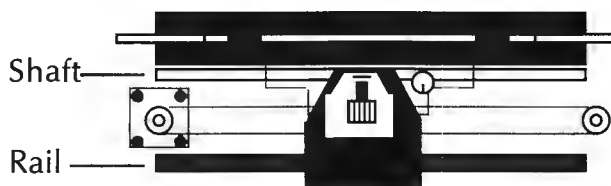
Symptoms: The ribbon cartridge deck jams while going to the left. The printout resembles a staircase, ascending to the right.

Probable diagnosis: There's too much friction on the carrier shaft and the carriage guide rail.

Solution: Thoroughly clean and lubricate the carrier shaft and the carriage guide rail.

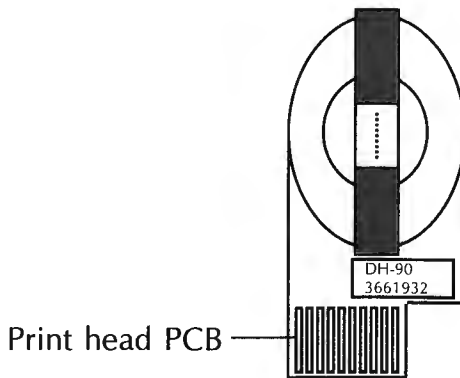
Symptoms: There are regularly spaced missing dots in the printout.

Probable diagnosis: The contacts on the print head PCB are dirty.

Solution: Clean the contacts with a pencil eraser. If that doesn't do it, see the next entry.

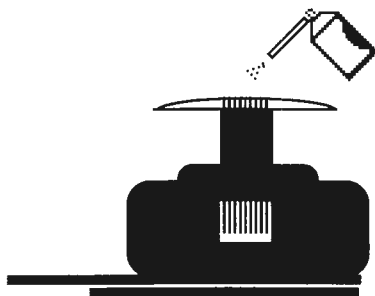
Symptoms: There are regularly spaced missing dots in the printout.

Probable diagnosis: One of the striker wires in the print head is rusty. The wire is hanging on the ribbon guide (instead of slipping through and onto the paper).

Solution: Spray the ribbon guide with a drop or two of WD-40. Let it soak in for several hours (preferably overnight) before reinstalling the print head. If that still doesn't do it, see the next entry.

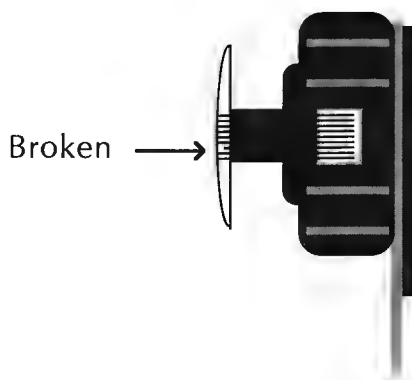
Symptoms: There are regularly spaced missing dots in the printout.

Probable diagnosis: One of the striker wires in the print head is bent or broken, and/or one of the return springs is weak.

Solution: Send out the print head (not the whole printer) to a service depot for repair. Also see the prior entry.

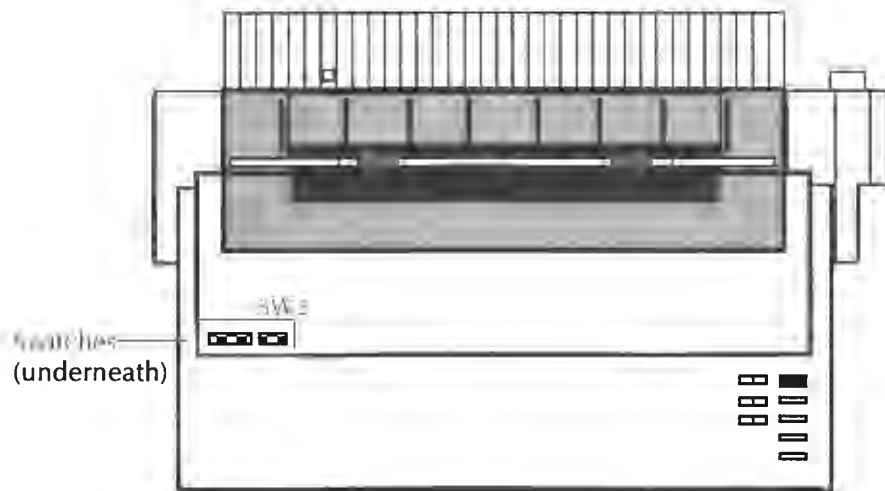
Symptoms: Best quality printing is wavy. Vertical lines are uneven.

Probable diagnosis: The character deviation is out of adjustment.

Solution: Adjust DIP switches SW2-5 and SW2-6 (located under the front cover) for best linearity. Also see the next entry.

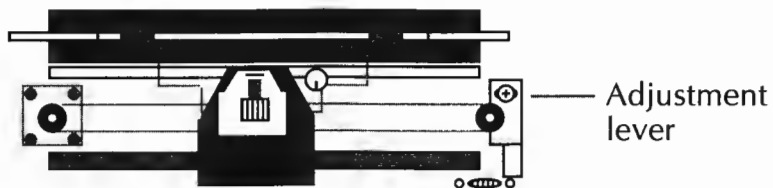
Symptoms: Best quality printing is wavy. Vertical lines are uneven.

Probable diagnosis: There's not enough tension on the carrier belt.

Solution: Adjust the carrier-belt tension lever (located under the front cover) for best linearity. If that doesn't do it, see the next entry.

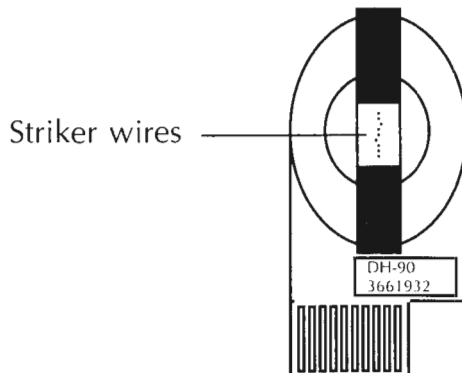
Symptoms: Best quality printing is wavy. Vertical lines are uneven.

Probable diagnosis: The striker wires in the print head are out of vertical alignment.

Solution: Send out the print head (not the whole printer) to a service depot for repair. If that's not it, see the next entry.

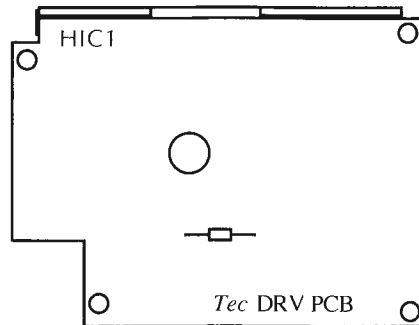
Symptoms: Best quality printing is wavy, blurred and/or almost double-struck. Vertical lines are uneven.

Probable diagnosis: The problem is on the ImageWriter II driver PCB.

Solution: Check/replace the EC-A051 IC (18-pin, carrier motor driver), C. Itoh part EAT-00-09900, at board reference HIC1.

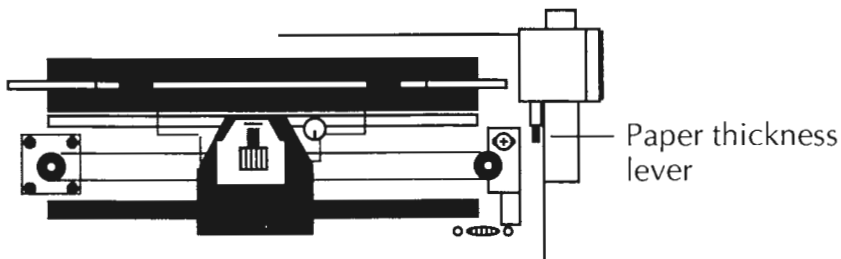
Symptoms: The printout is too light.

Probable diagnosis: The paper thickness lever is too far back.

Solution: Move the paper thickness lever (located under the front cover) closer to the platen. If that doesn't do it, see the next entry.

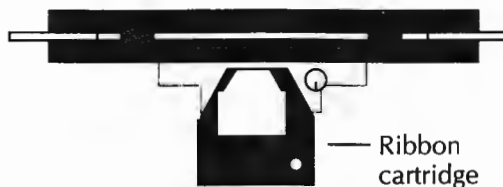
Symptoms: The printout is too light.

Probable diagnosis: The ribbon cartridge is dry or worn out.

Solution: Replace the ribbon cartridge, C. Itoh part CLABK-128S2. Also see the prior entry.

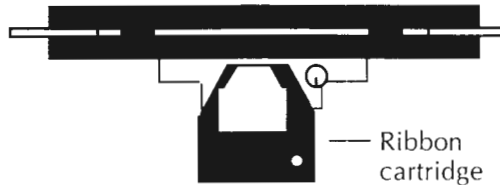
Symptoms: There are intermittent dropouts in the printout. Some areas are dark, and some areas are light.

Probable diagnosis: The ribbon cartridge is worn or defective.

Solution: Replace the ribbon cartridge, C. Itoh part CLABK-128S2.

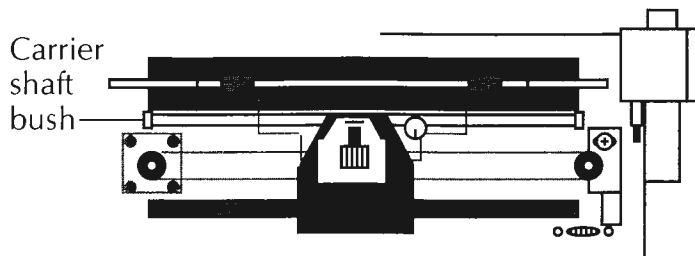
Symptoms: The printout fades from dark to light (or from light to dark). One side of the printout is darker or lighter than the other.

Probable diagnosis: The carrier shaft isn't square to the platen. The side farthest away is where the printing is the lightest.

Solution: Square the carrier shaft to the platen by installing a 0.002-inch, 0.004-inch or 0.008-inch adjust plate (C. Itoh part numbers CBA20-02901, CBA20-02902 and CBA20-02903), on the carrier shaft bush located on the side where printing is the lightest, or by removing a 0.002-inch, 0.004-inch or 0.008-inch adjust plate from the carrier shaft bush located on the side where printing is the darkest.

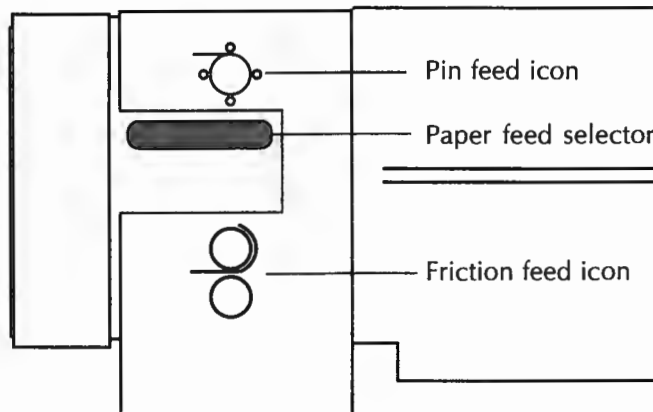
Symptoms: After a few pages, the pin-feed paper derails and the printer jams.

Probable diagnosis: The paper feed selector (located on the right leg) is positioned for friction-feed paper (not pin-feed).

Solution: Push the paper feed selector toward the pin-feed icon.

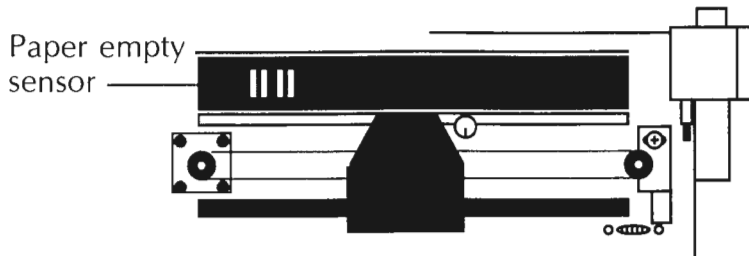
Probable diagnosis: The paper empty sensor is malfunctioning. Most likely, a mailing label is stuck under the platen.

Solution: Remove the platen. Clear the stuck mailing label.

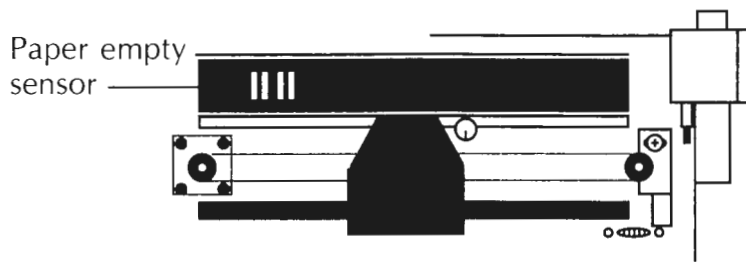
Symptoms: It's hard to load paper. Something seems to be blocking the paper path.

Probable diagnosis: A mailing label is or was stuck under the platen, and/or the arms on the mechanical paper empty sensor are bent.

Solution: Remove the platen. Clear the stuck mailing label, if any, and straighten the arms on the paper empty sensor, if necessary.

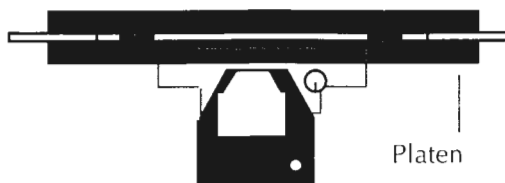
Symptoms: Cut-sheet paper slips and lines overprint in friction-feed mode.

Probable diagnosis: The platen is slipping. It's lost its grip!

Solution: Restore the platen grip with liquid tape-recorder rubber cleaner, Teac RC1 or equivalent, and a clean cotton rag.

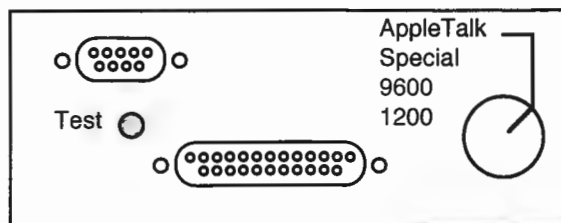
Symptoms: On a LaserWriter, there's no test page. The green Test LED on the interface panel comes on and remains on (does not shut off).

Probable diagnosis: The problem is on the LaserWriter logic board.

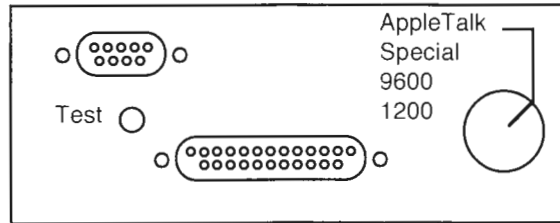
Symptoms: On a LaserWriter, there's no test page. The green Test LED on the interface panel *never* comes on (doesn't even blink once).

Probable diagnosis: The problem is on the LaserWriter logic board.

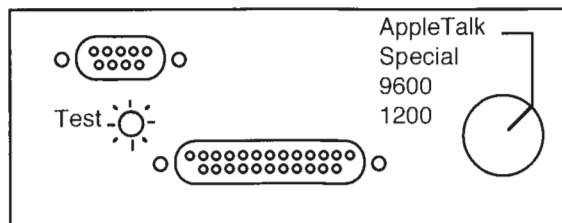
Symptoms: On a LaserWriter, there's no test page. The green Test LED on the interface panel is blinking.

Probable diagnosis: The problem is on the LaserWriter logic board.

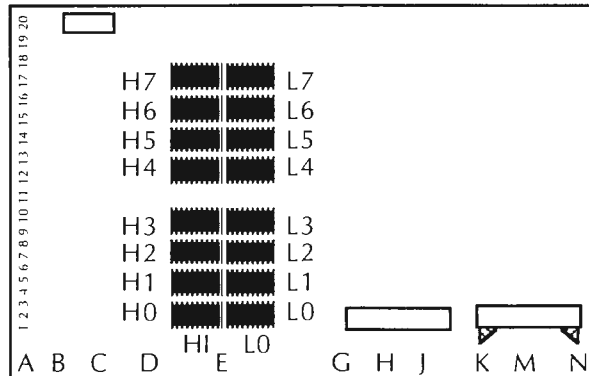
Symptoms: On a LaserWriter Plus, there's no test page. The green Test LED on the interface panel comes on and remains on (does not shut off). Test Character Generator version 2.0 (on *The Dead Mac Scrolls Disk*) or other diagnostics software reports error code nnnnnn01 (where the value of nnnnnn is insignificant).

Probable diagnosis: The problem is on the LaserWriter Plus logic board.

Solution: Check/replace the version-2 ROMs marked H0 and L0.

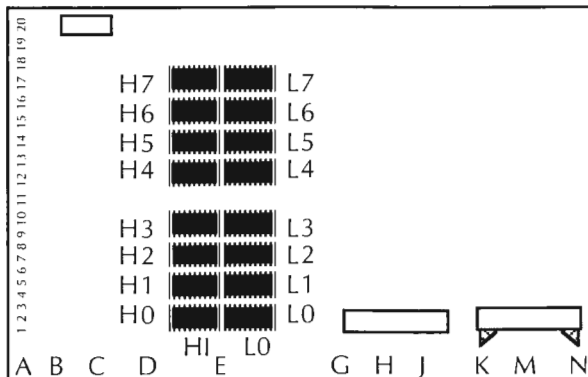
Symptoms: On a LaserWriter Plus, there's no test page. The green Test LED on the interface panel is blinking. Test Character Generator version 2.0 (on *The Dead Mac Scrolls Disk*) or other diagnostics software reports error code nnnnnn02 (where the value of nnnnnn is insignificant).

Probable diagnosis: The problem is on the LaserWriter Plus logic board.

Solution: Check/replace the version-2 ROMs marked H1 and L1.

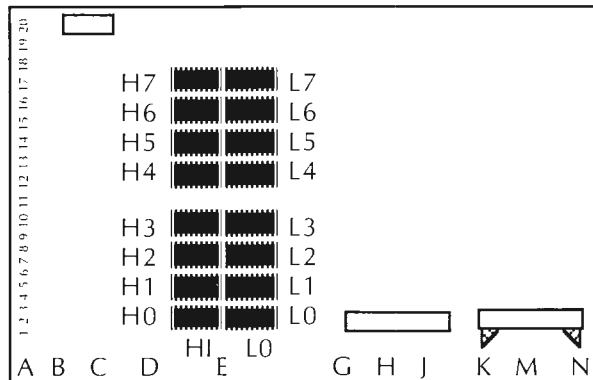
Symptoms: On a LaserWriter Plus, there's no test page. The green Test LED on the interface panel is blinking. Test Character Generator version 2.0 (on *The Dead Mac Scrolls Disk*) or other diagnostics software reports error code nnnnnn04 (where the value of nnnnnn is insignificant).

Probable diagnosis: The problem is on the LaserWriter Plus logic board.

Solution: Check/replace the version-2 ROMs marked H2 and L2.

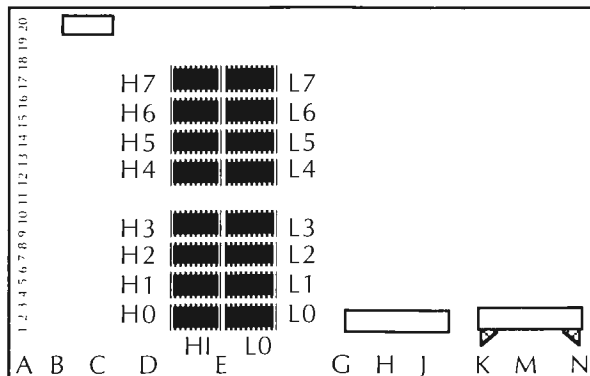
Symptoms: On a LaserWriter Plus, there's no test page. The green Test LED on the interface panel is blinking. Test Character Generator version 2.0 (on *The Dead Mac Scrolls Disk*) or other diagnostics software reports error code nnnnnn08 (where the value of nnnnnn is insignificant).

Probable diagnosis: The problem is on the LaserWriter Plus logic board.

Solution: Check/replace the version-2 ROMs marked H3 and L3.

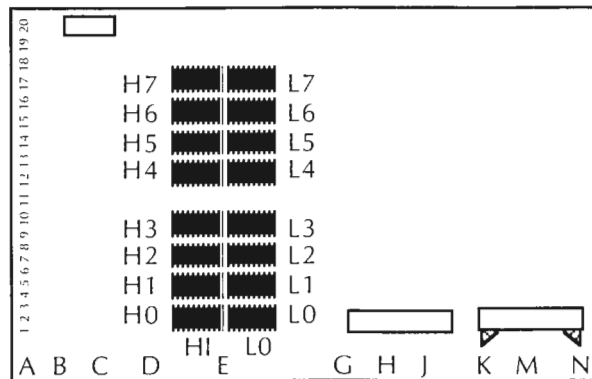
Symptoms: On a LaserWriter Plus, there's no test page. The green Test LED on the interface panel is blinking. Test Character Generator version 2.0 (on *The Dead Mac Scrolls Disk*) or other diagnostics software reports error code nnnnnn10 (where the value of nnnnnn is insignificant).

Probable diagnosis: The problem is on the LaserWriter Plus logic board.

Solution: Check/replace the version-2 ROMs marked H4 and L4.

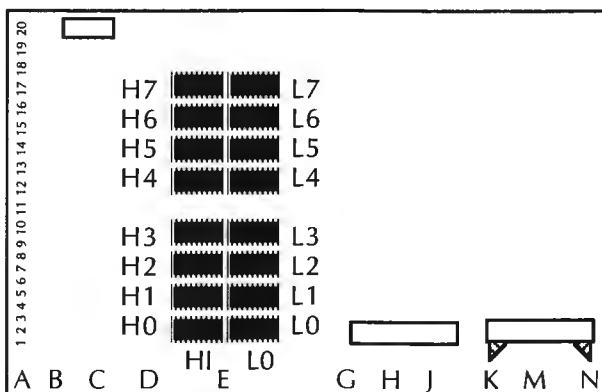
Probable diagnosis: The problem is on the LaserWriter Plus logic board.

Solution: Check/replace the version-2 ROMs marked H5 and L5.

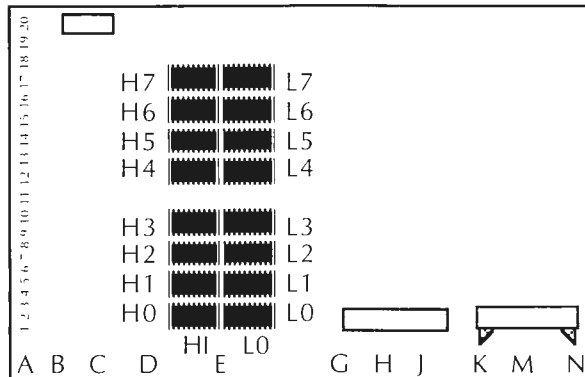
Symptoms: On a LaserWriter Plus, there's no test page. The green Test LED on the interface panel is blinking. Test Character Generator version 2.0 (on *The Dead Mac Scrolls Disk*) or other diagnostics software reports error code nnnnnn40 (where the value of nnnnnn is insignificant).

Probable diagnosis: The problem is on the LaserWriter Plus logic board.

Solution: Check/replace the version-2 ROMs marked H6 and L6.

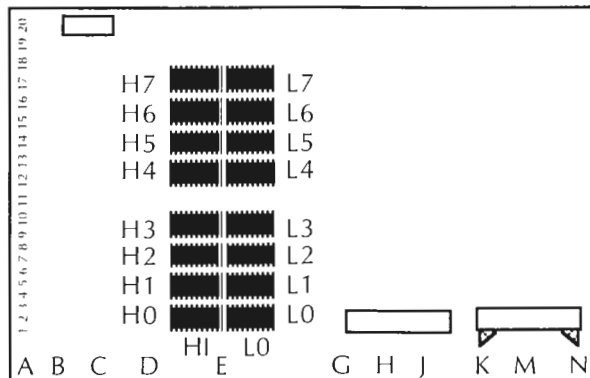
Probable diagnosis: The problem is on the LaserWriter Plus logic board.

Solution: Check/replace the version-3 ROMs marked H7 and L7.

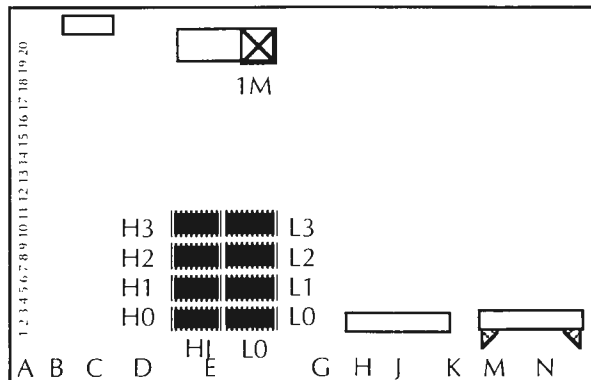
Symptoms: On a LaserWriter Plus, there's no test page. The green Test LED on the interface panel comes on and remains on (does not shut off). Test Character Generator version 2.0 (on *The Dead Mac Scrolls Disk*) or other LaserWriter Plus diagnostics software reports error code nnnnnn03 (where the value of nnnnnn is insignificant).

Probable diagnosis: The problem is on the LaserWriter Plus logic board.

Solution: Check/replace the version-3 ROMs marked H0 and L0.

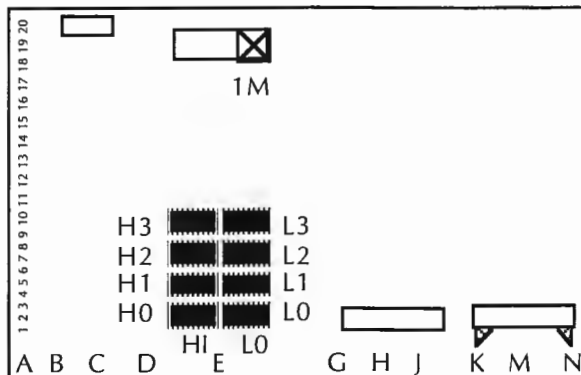
Symptoms: On a LaserWriter Plus, there's no test page. The green Test LED on the interface panel is blinking. Test Character Generator version 2.0 (on *The Dead Mac Scrolls Disk*) or other diagnostics software reports error code nnnnnn0C (where the value of nnnnnn is insignificant).

Probable diagnosis: The problem is on the LaserWriter Plus logic board.

Solution: Check/replace the version-3 ROMs marked H1 and L1.

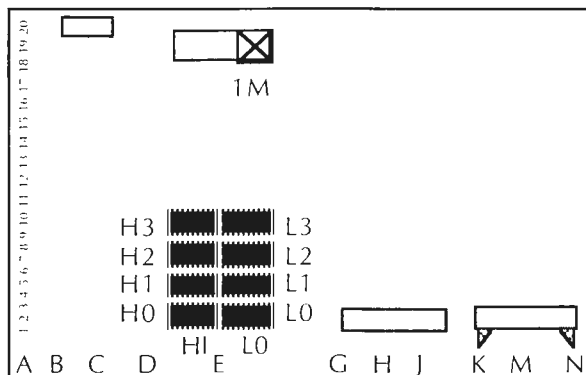
Symptoms: On a LaserWriter Plus, there's no test page. The green Test LED on the interface panel is blinking. Test Character Generator version 2.0 (on *The Dead Mac Scrolls Disk*) or other diagnostics software reports error code nnnnnn30 (where the value of nnnnnn is insignificant).

Probable diagnosis: The problem is on the LaserWriter Plus logic board.

Solution: Check/replace the version-3 ROMs marked H2 and L2.

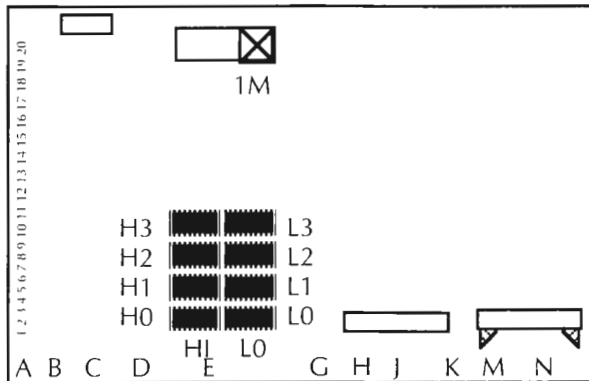
Symptoms: On a LaserWriter Plus, there's no test page. The green Test LED on the interface panel is blinking. Test Character Generator version 2.0 (on *The Dead Mac Scrolls Disk*) or other diagnostics software reports error code nnnnnnC0 (where the value of nnnnnn is insignificant).

Probable diagnosis: The problem is on the LaserWriter Plus logic board.

Solution: Check/replace the version-3 ROMs marked H3 and L3.

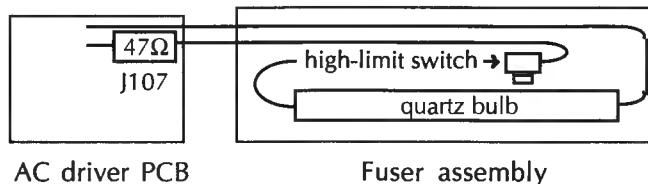
Symptoms: On powerup, the *ready/wait* light (located on the status panel) blinks for a minute or so, then lights continuously as usual, but there's no test page. The printer *is* recognized in the Chooser, but there's no response to the print command.

Probable diagnosis: The problem is in the fuser assembly and/or on the upper AC driver PCB (both located in the printer's lower unit).

Solution: Check/replace the quartz-heater bulb (HP part RH7-4007-000CN) in the fuser assembly and check/replace current limiting resistor J107 (47Ω , $\frac{1}{4}$ -watt, 5%) on the upper AC driver PCB. If that doesn't do it, see the next entry.

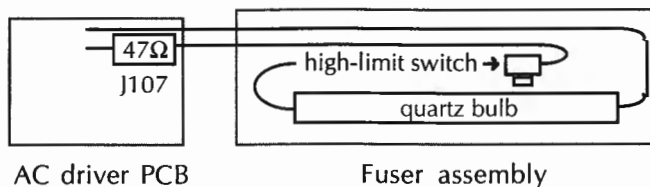
Symptoms: On powerup, the *ready/wait* light (located on the status panel) blinks for a minute or so, then lights continuously as usual, but there's no test page. The printer *is* recognized in the Chooser, but there's no response to the print command.

Probable diagnosis: The problem is in the fuser assembly.

Solution: Check/replace the high-limit switch (HP part FH7-7041-000CN). If that's not it, see the next entry.

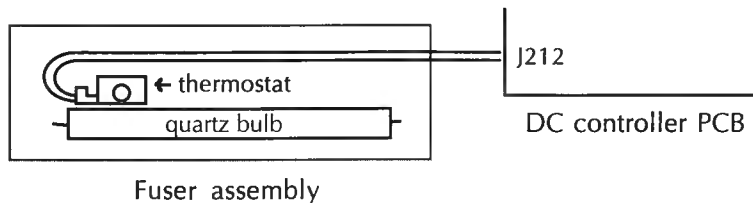
Symptoms: On powerup, the *ready/wait* light (located on the status panel) blinks for a minute or so, then lights continuously as usual, but there's no test page. The printer *is* recognized in the Chooser, but there's no response to the print command.

Probable diagnosis: The problem is still in the fuser assembly.

Solution: Check/replace the fuser thermostat (HP part RH7-7002-000CN). Also see the prior entry.

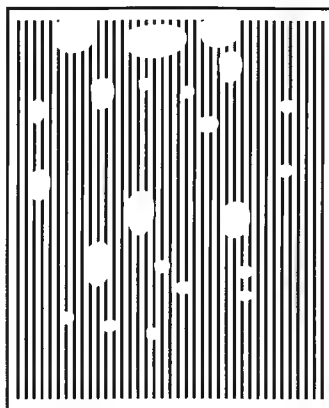
Symptoms: There are white water spots (dropouts) on the printout.

Probable diagnosis: The toner is unevenly distributed.

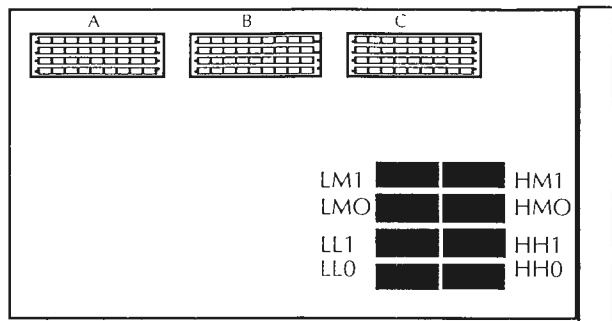
Probable diagnosis: The problem is on the LaserWriter II NTX I/O board.

Solution: Check/replace the SIMMs in banks A, B and C.

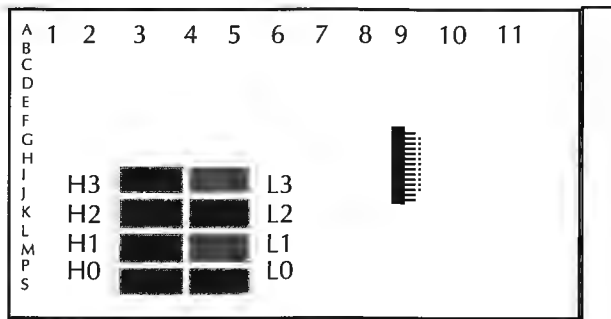
Symptoms: There's no test page on a LaserWriter II NT. The *paper jam* light is blinking red, but there's no paper jam. The self-test (print engine test) works OK.

Probable diagnosis: The problem is on the LaserWriter II NT logic board.

Solution: Check/replace the ROMs marked H2/L2 and H1/L1.
