THE MACINTOSH
BIBLE GUIDE
TO SAVING A FORTUNE
ON MAC REPAIRS

THE DEAD MAC SCROLLS

HOW TO FIX HUNDREDS
OF HARDWARE PROBLEMS
WITHOUT GOING BANKRUPT

LARRY PINA

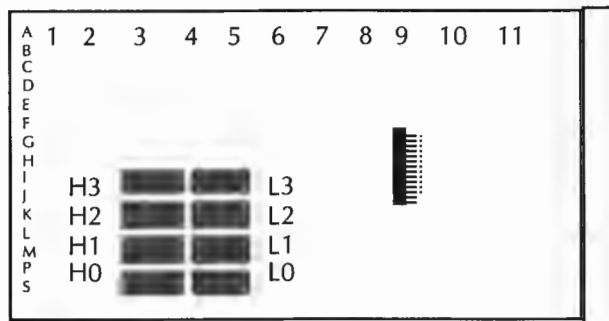
Symptoms: There's no test page on a LaserWriter II NT. The status panel never lights up, but the self-test (print engine) works OK.

Probable diagnosis: The problem is on the LaserWriter II NT logic board.

Solution: Check/replace the ROMs marked H3/L3 and H0/L0.

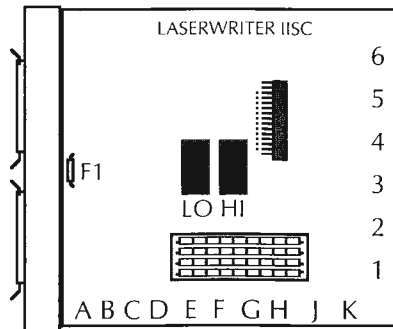
Probable diagnosis: The problem is on the LaserWriter II SC logic board.

Solution: Check/replace the SIMMs at board references D1 to J1.

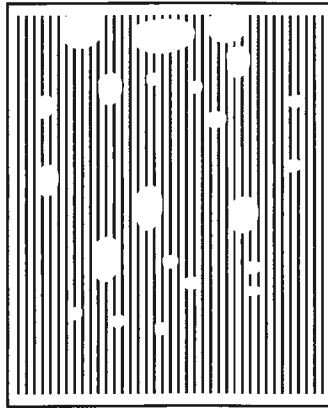
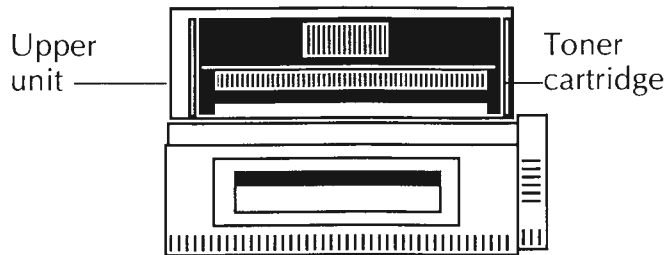
Symptoms: There are irregularly spaced white spots on every page.

Probable diagnosis: The toner is unevenly distributed.

Solution: Check/replace the toner cartridge (HP part 92295A).

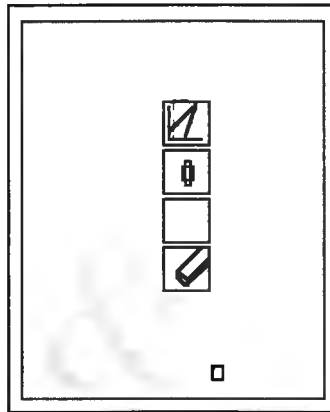
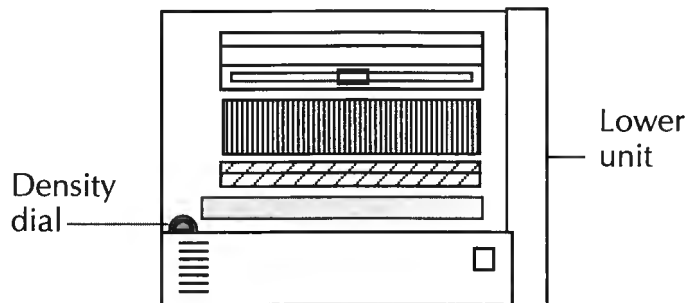
Symptoms: The printout is generally too light.

Probable diagnosis: The print-density dial is set too high. The higher the setting, the lighter the printout.

Solution: Turn the print-density dial to a lower number or fully counterclockwise for the darkest possible printout.

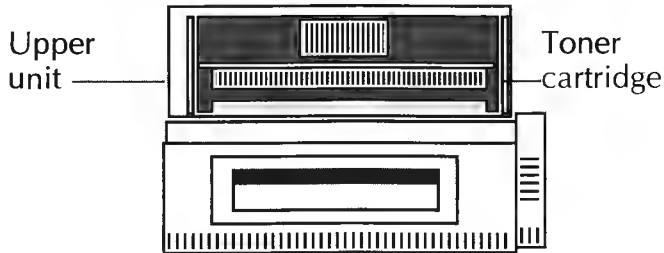
Probable diagnosis: The toner cartridge is empty.

Solution: Check/replace the toner cartridge (HP part 92295A) located in the printer's upper unit.

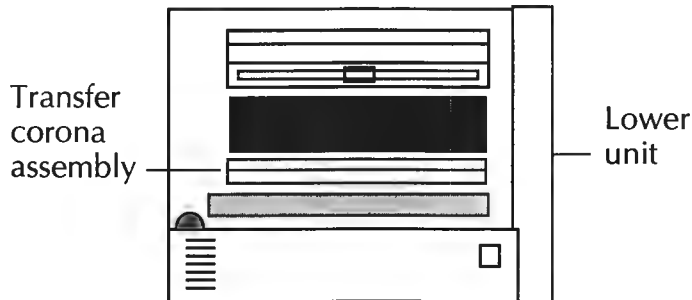
Symptoms: Solid blacks appear to have been blotted. The edges are rough, not crisp.

Probable diagnosis: The problem is in the transfer corona assembly (located in the lower unit).

Solution: Clean/tighten the transfer corona assembly.

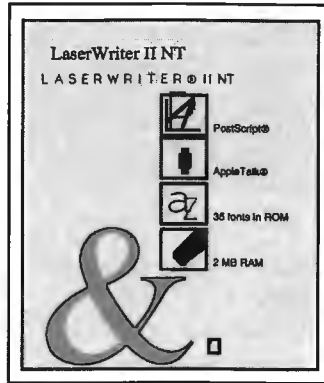
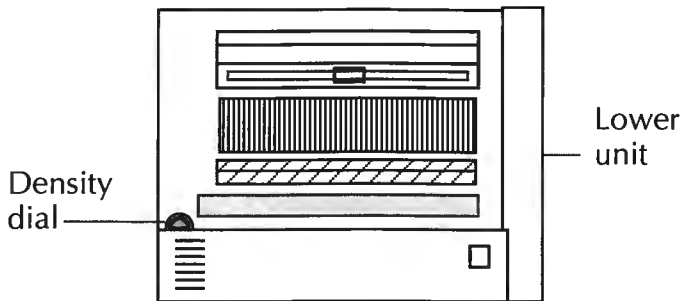
Symptoms: The printout is generally too dark.

Probable diagnosis: The print-density dial is set too low. The lower the setting, the darker the printout.

Solution: Turn the print-density dial to a higher number or fully clockwise for the lightest possible printout.

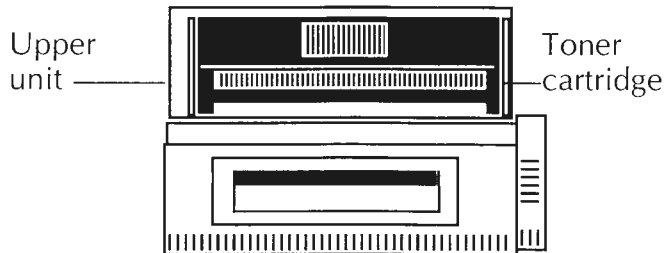
Symptoms: Every printout, including the test page, is solid white.

Typical history: The problem occurred right after you installed a new toner cartridge.

Probable diagnosis: The sealing tape is still in the toner cartridge.

Solution: Check/remove the factory sealing tape.

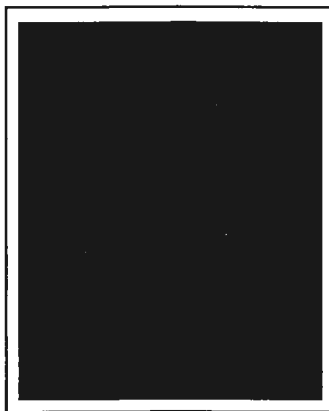
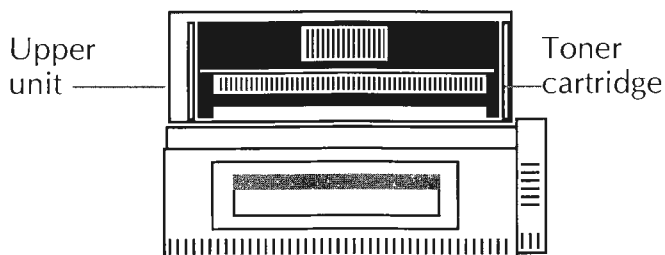
Symptoms: Every printout, including the test page, is solid black.

Probable diagnosis: The problem is in the toner cartridge.

Solution: Check/replace the toner cartridge (HP part 92295A).

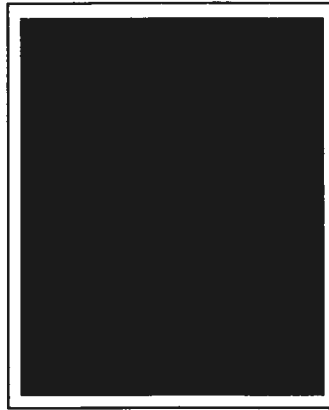
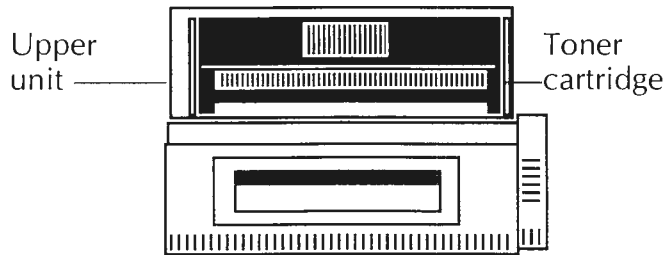
Symptoms: Every printout, including the test page, is solid gray.

Probable diagnosis: The problem is in the toner cartridge.

Solution: Check/replace the toner cartridge (HP part 92295A).

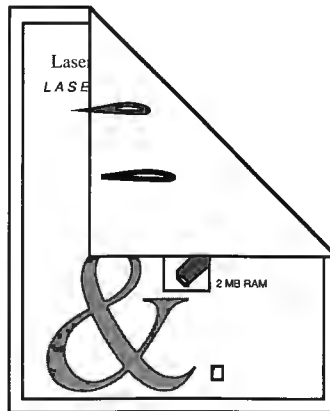
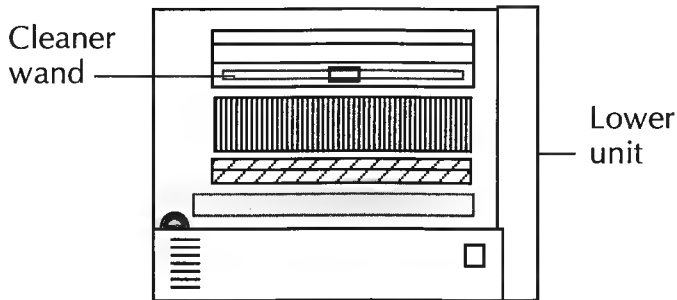
Symptoms: There are stains on the back of every printed page.

Probable diagnosis: The problem is in the fuser assembly.

Solution: Check/replace the fixing roller cleaner wand (HP part RG1-0966-000).

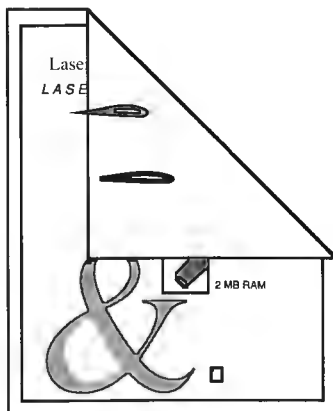
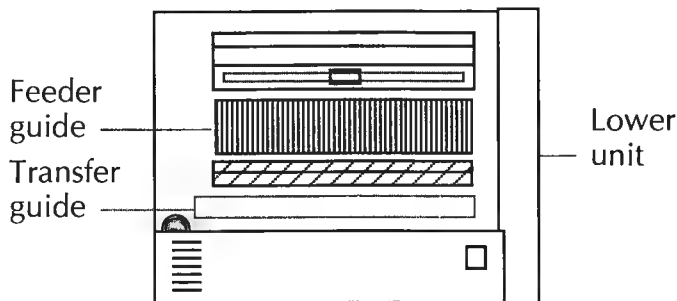
Symptoms: There are stains on the back of every printed page.

Probable diagnosis: The lower unit is dirty.

Solution: Clean the lower unit, particularly the black plastic feeder guide and brass-color transfer guide.

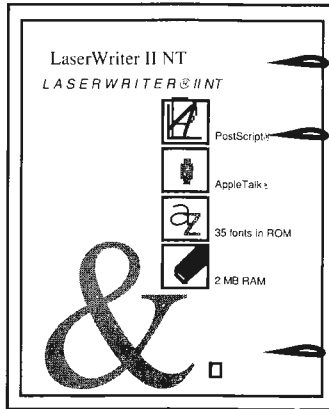
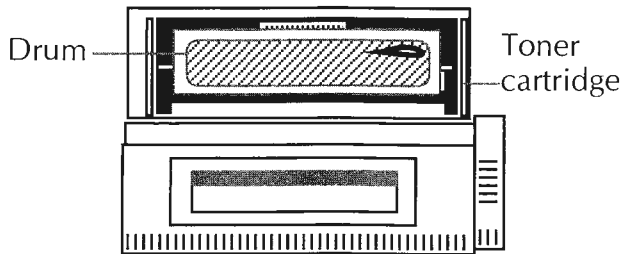
Symptoms: There are black marks on one side of every page.

Probable diagnosis: The photosensitive drum needs cleaning.

Solution: Clean the affected edge of the photosensitive drum. If the problem recurs, replace the toner cartridge (HP part 92295A).

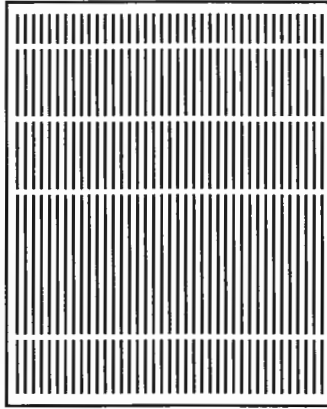
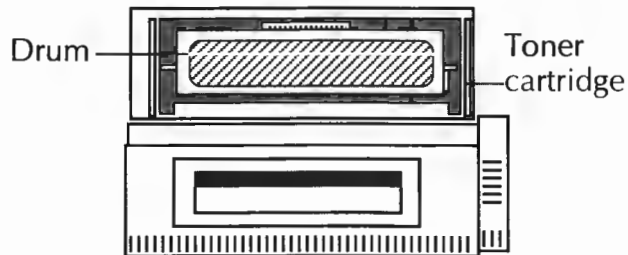
Symptoms: There are regularly spaced horizontal white lines on every page.

Probable diagnosis: The photosensitive drum is scarred.

Solution: Check/replace the toner cartridge (HP part 92295A).

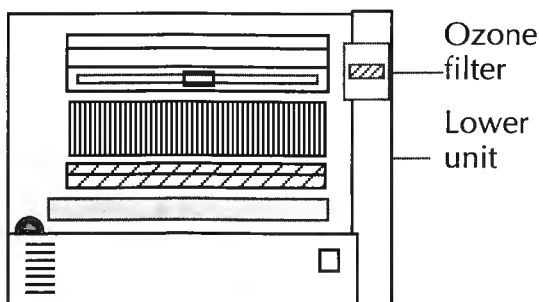
Symptoms: An ozone (auto-exhaust) smell lingers about the printer. Other than that, it seems OK.

Probable diagnosis: The ozone filter is allowing gas to escape.

Solution: Check/replace the ozone filter.
